PREVOST

WARRANTY BULLETIN

WB14-28E

DATE :	OCTOBER 2014	SECTION :	23 - Accessories
EXPIRATION:	OCTOBER 2016		
SUBJECT :	AFSS LINEAR THERMAL DETECTOR (LTD) REPLACEMENT AND RELOCATION OF IR SENSOR

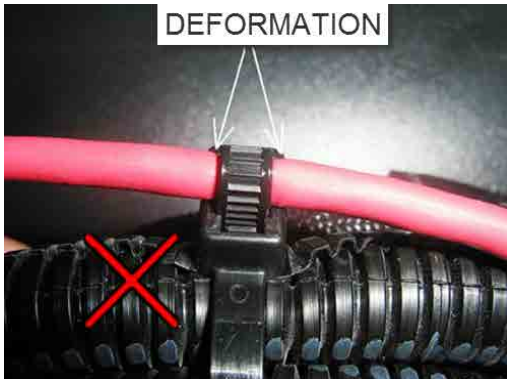
NOT ALLOWED

Cable tie tighten in excess on the LTD. Tighten cable tie on LTD by hand only. Tighten just enough to prevent LTD from slipping from once side to the other inside the cable tie loop
