DRIVE AXLE CRADLE TRIPOD MEMBER INSPECTION AND REPLACEMENT

Prevost vehicles

On the vehicles affected by this bulletin, replace the rear tripod member.

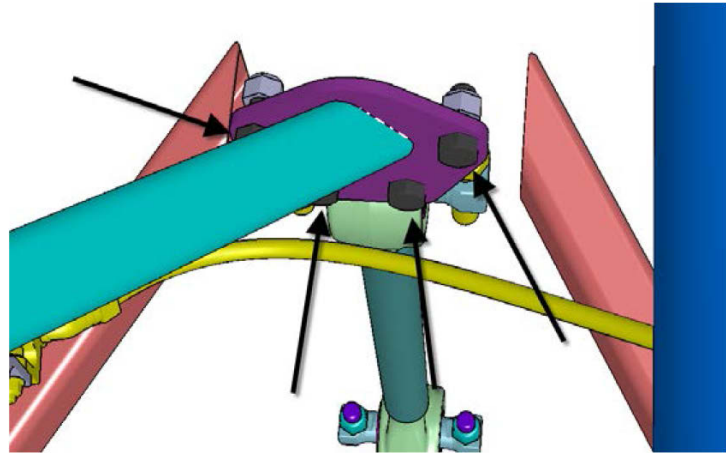
Inspect screws to make sure they do not present any excessive corrosion or damage. Keep screws and washers (if used) for re-use.

4. To replace the rear tripod member, unscrew the top hardware (4).
5. Discard the nylon locking nuts.

Replace screws as required with new #5001590 M16x40 G10.9 hex cap screw.

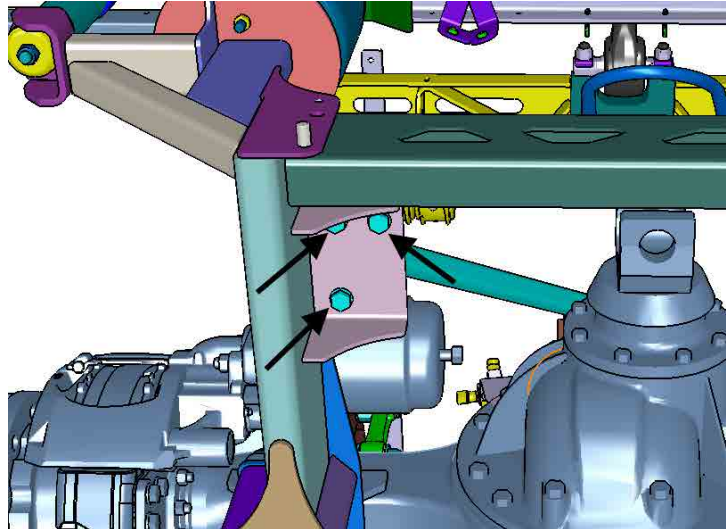
Inspect screws to make sure they do not present any excessive corrosion or damage. Keep screws and washers for re-use.

6. Unscrew the bottom hardware (3).
7. Discard the nylon locking nuts

Replace screws as required with new #5001372 M16x50 G10.9 hex cap screw.
