PREVOST

**WARRANTY
BULLETIN**

WB14-08C

| SUBJECT : | GATEWAY MODULE REPLACEMENT | | |

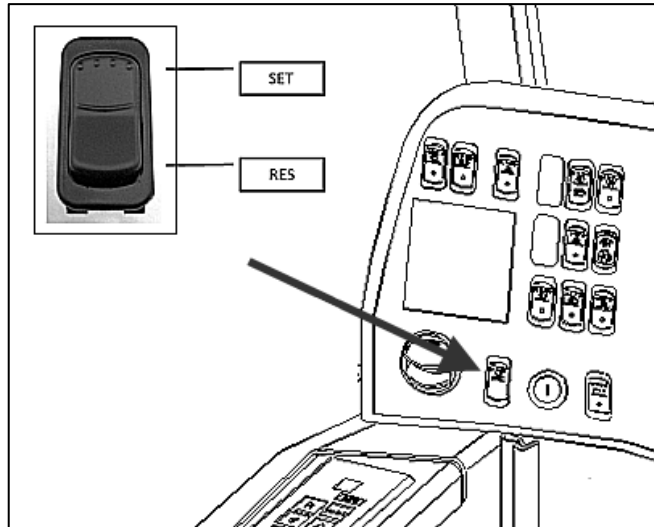
Figure 1

First identify if vehicle has a *temporary cruise set/resume switch* on the left dashboard.

STEP A will detail how to remove the temporary cruise control switch installation.
