## SEAT BASE WELD INSPECTION AMAYA Prevost vehicles

### DESCRIPTION

On the vehicles affected by this bulletin, for all fixed (non-sliding) passenger seats, inspect the presence or absence of weld on the seat wall bracket. Refer to images for exact location. Record inspection results in work order line text. If inspection reveals a defect, replace the seat frame.

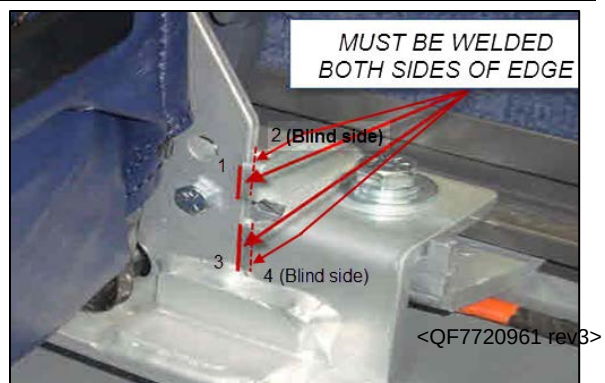
Figure 1

- For all fixed (non-sliding) seats with wall bracket, inspect for presence or absence of weld in these locations.

- 2) Four weld beads must be present on the bracket. Two on aisle side and two on wall (blind) side, (fig.1).

On the defective seat, remove backrest and cushions and accessories. Install them on the new frame.

Use part 865442 for RH (curb side) seats.

Use part 865443 for LH (road side) seats.

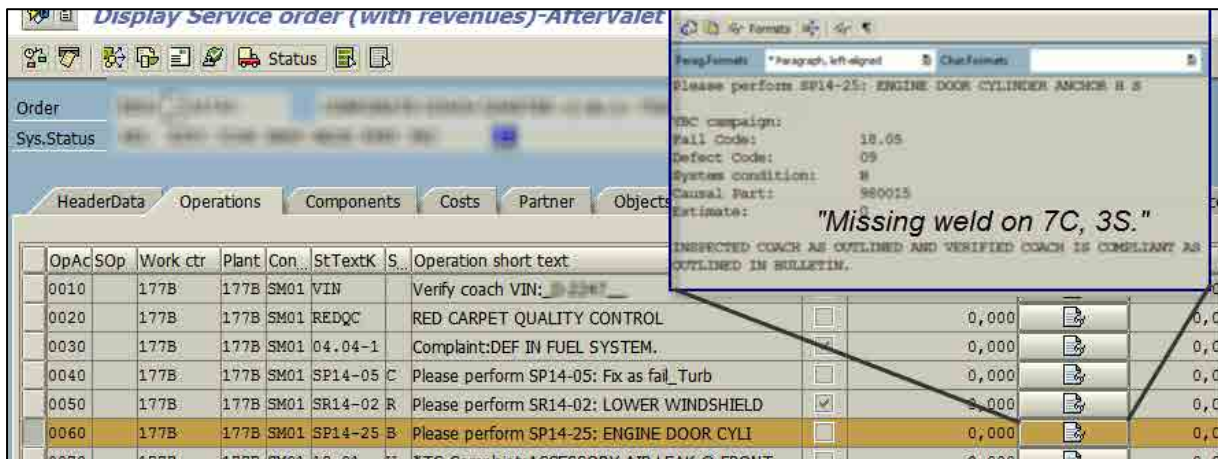
Figure 2

- 3) For each seat with a missing weld, write down inspection results and seat position in SAP service order line text. (fig. 2)

Type seat row number\* plus **Curb** or **Street side**. \*(Row 1, front of coach)

**Ex:** "Missing welds on 7C, 3S." etc.
