# Whistle Noise from Exterior Mirror

## Applicability

YEAR(S)	MODEL(S)	ADDITIONAL INFORMATION
2014	4Runner

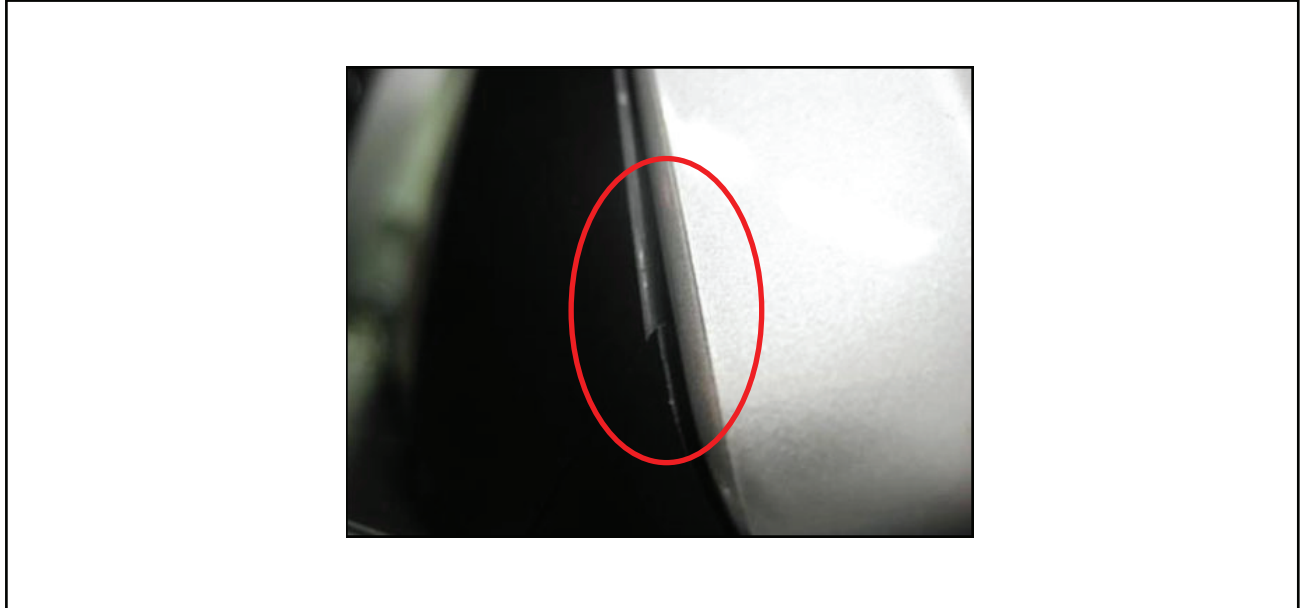
**Figure 1.**

Some 2014 model year 4Runner vehicles may exhibit a whistle noise coming from the mirror assembly while driving. A gap may be present at the inside corner of the outer mirror cover and mirror housing assembly junction.

Follow the procedure outlined below to address this condition.

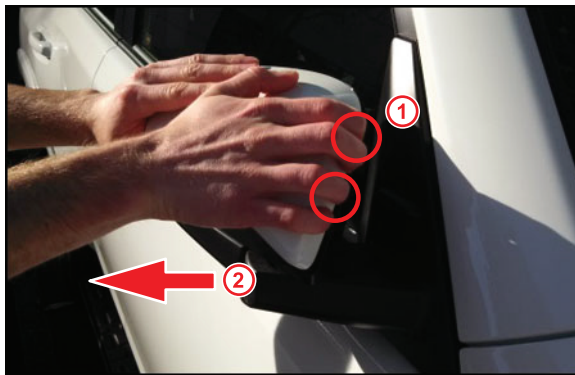
Figure 2.

1	Pressure Points
2	Pull Away Direction

2. Remove the outer mirror cover.
  - A. Apply pressure from the front side of the outer mirror cover to disengage the clips.
  - B. Carefully pull the outer mirror cover away as shown below.

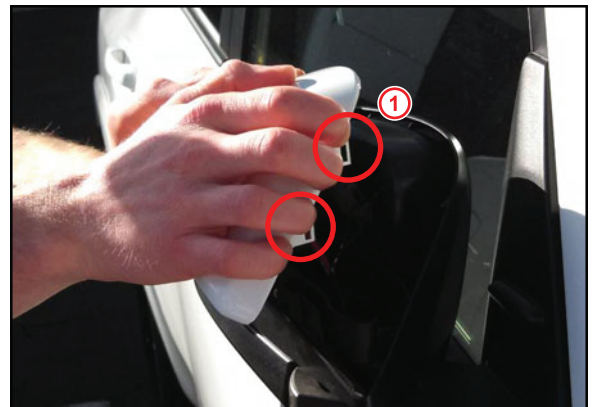
Figure 3.

1	Outer Mirror Cover Clips
---	--------------------------

Use caution when removing the outer mirror cover as to NOT damage or drop the cover.

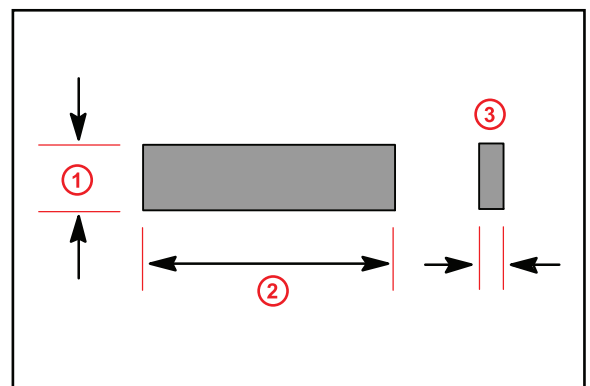
Figure 4.

1	10 mm
2	26 mm
3	3 mm

3. From the Wind Noise Kit, cut a section of felt to the following dimensions:

Length: 26 mm

Width: 10 mm

Thickness: 3 mm

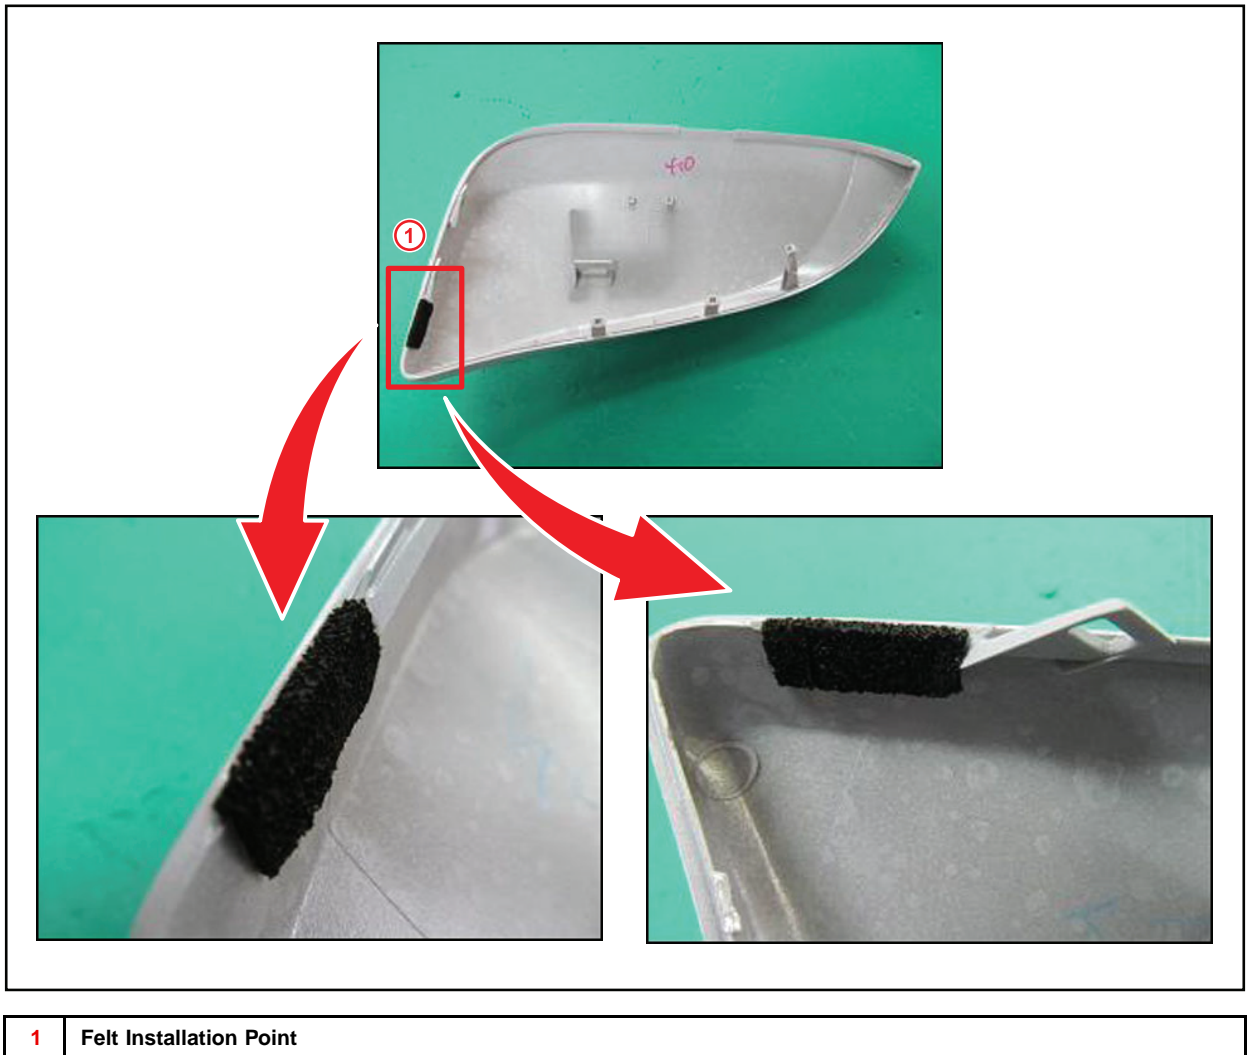
Figure 5. Felt Location on Outer Mirror Cover (Driver Side)

4. Apply the felt to the outer mirror cover as shown.

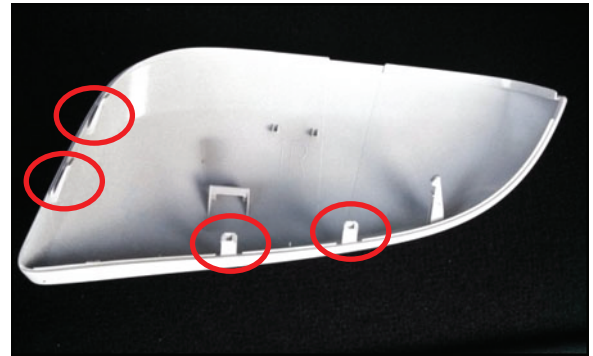
**Figure 6. Clip Locations on Outer Mirror Cover (Driver Side)**

5. Reassemble the mirror by carefully aligning the clips at the circled locations and pressing until engagement.

**HINT**  
 Make sure the felt is not visible with the mirror installed.

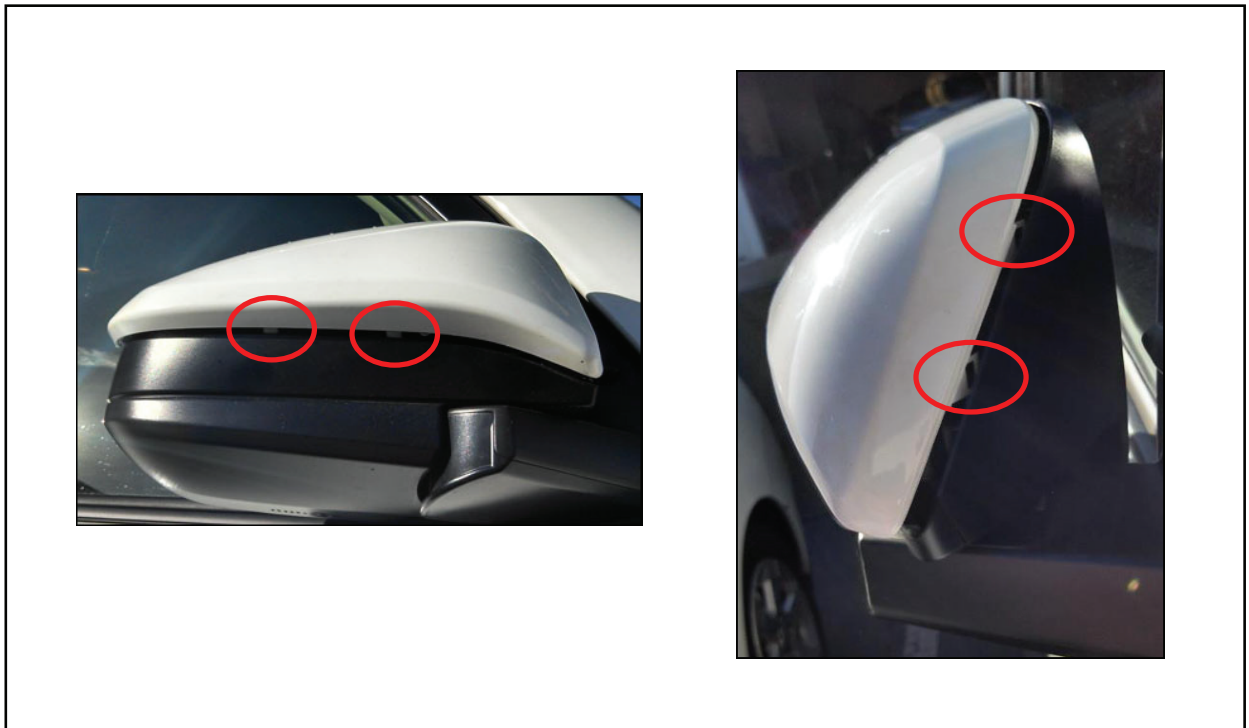
**Figure 7. Installed Clip Locations on Outer Mirror Cover (Passenger Side)**
