YEAR(S)	MODEL(S)	ADDITIONAL INFORMATION
2014	Tacoma

T-SB-0025-14 April 15, 2014 Page 2 of 12

## **Blower Motor Only Operates on High Speed**

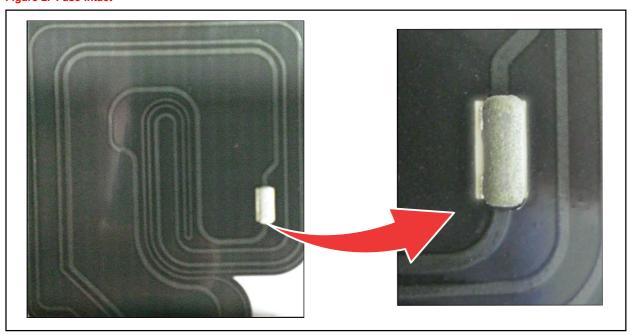
Figure 2. Fuse Intact

Inspect the fuse. Is the fuse intact?

- YES Continue to step 4.
- NO This bulletin does NOT apply. Continue diagnosis using the applicable Repair Manual.

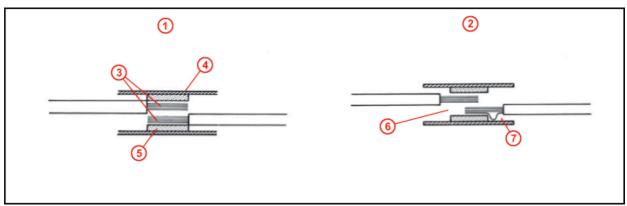
Figure 7.

1	Good Example
2	Bad Example
3	2 Stripped Wires
4	Sleeve (Blue)

5	Pressure-Contact Section
6	Wire in Short Position
7	Wire Bend

8. Crimp the replacement terminal lead to the harness lead.

- A. Overlap the 2 stripped wire ends inside the sleeve as shown.
- B. Place the sleeve into the 8 mm crimp die of the Wire Crimper (Non Insulated).
