Radio Screen Brightness Difference Between Modes

YEAR(S)	MODEL(S)	ADDITIONAL INFORMATION
2013	RAV4

Some 2013 model year RAV4 vehicles may exhibit a condition where the radio screen brightness varies noticeably between the audio and map/APPs screens, and/or the map/APPs screen is difficult to see. Follow the procedures in this bulletin to update the radio software in order to equalize the screen brightness.

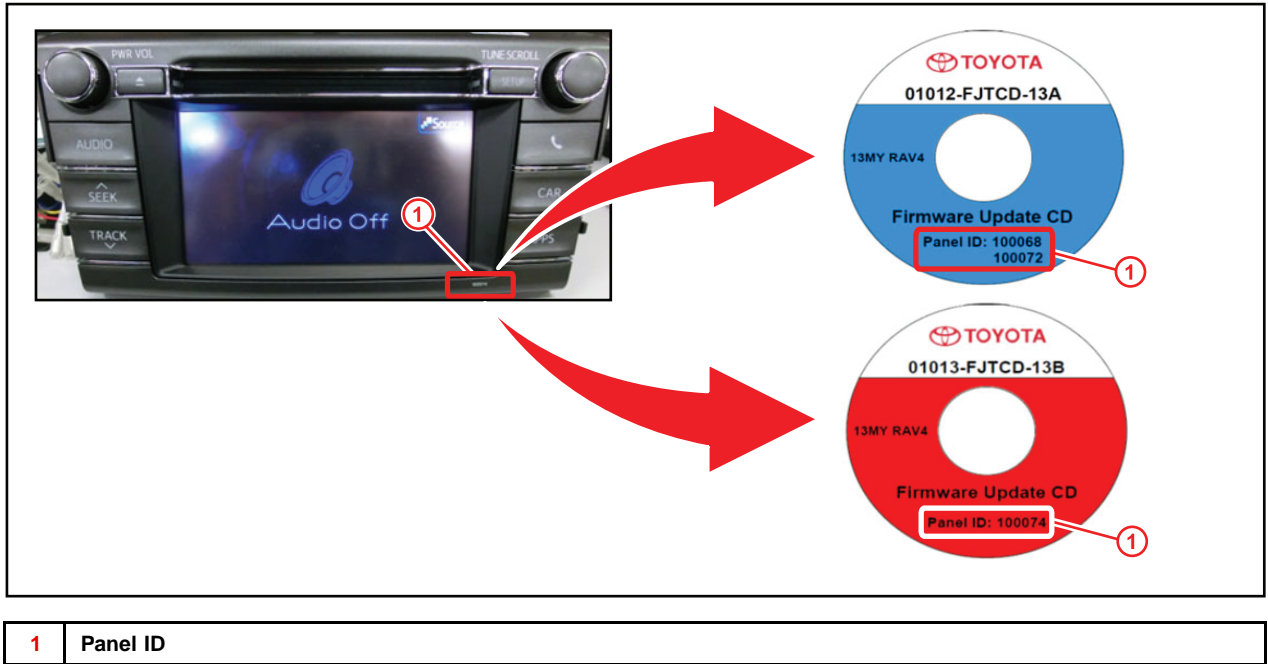
Figure 1.

SPECIAL SERVICE TOOLS (SST)	PART NUMBER	RADIO ASSEMBLY PART NUMBER	PANEL ID	DISC COLOR
CD Firmware Update - Fujitsu Ten	01012-FJTCD-13A	86140-42020	100068	Blue
		86140-0R020	100072	
	01013-FJTCD-13B	86140-0R040	100074	Red
