2nd Row Tip-Up Style Seat Lower Cushion Excessive Movement

Service Category Vehicle Interior

Section Seat

YEAR(S)	MODEL(S)	ADDITIONAL INFORMATION
2011 – 2014	Sienna

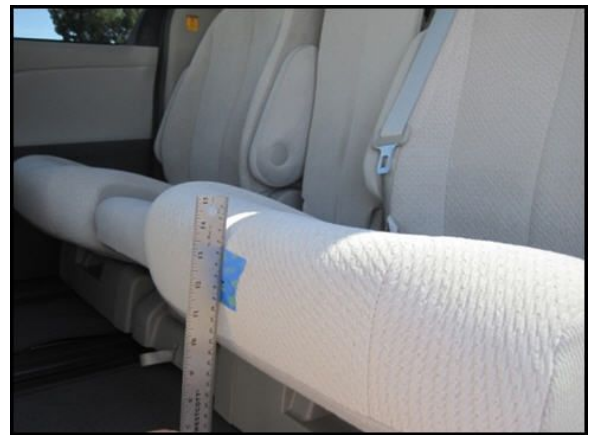
Figure 1. Example of Seat Measurement

1. Confirm amount of lower seat cushion movement.
 - A. Latch the lower seat cushion into place.
 - B. Apply downwards pressure at the center of the lower seat cushion to verify the amount of movement present in the seat cushion frame assembly.
2. While applying pressure, measure the amount of movement in the lower cushion assembly.
 - A. Apply tape to the front edge of the cushion.
 - B. Draw a reference line on the tape.
 - C. Using a metric ruler, measure vertical movement of the lower cushion.

MEASUREMENT	INSPECTION RESULT	REPAIR	OP CODE
0 – 3 mm	Normal characteristic (within specification)	None	None
4 – 12 mm	Excessive movement	Repair Procedure 1	BD1223
13+ mm	Seat latch mechanism damaged (replacement required)	Repair Procedure 2	See table in Repair Procedure 2, step 2

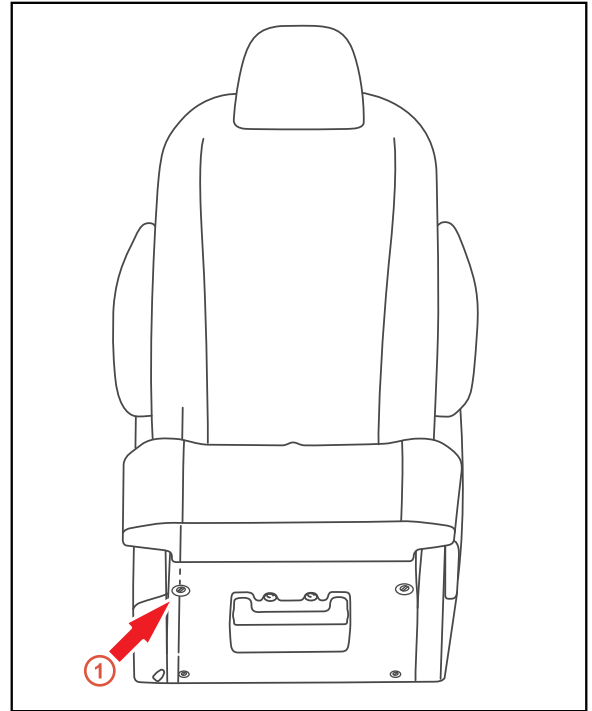
Figure 2.

1	Seat Support Cushion
----------	-----------------------------

1. Tip up lower cushion to gain access to the seat support cushions.

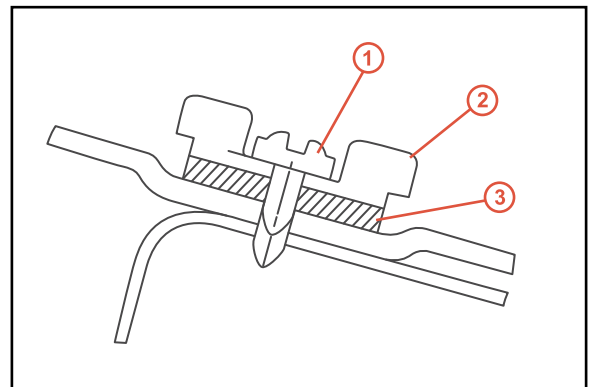
Figure 3.

1	Screw
2	Seat Support Cushion
3	Shim

2. Remove the seat support cushions and screws.
3. Install the 3 mm shim to the bottom of the seat support cushions and reinstall the seat support cushions and screws.

NOTE
 For vehicles built before 12/2011, a new seat support cushion and screw are required to properly install the 3 mm shim.
