# Entune Audio Head Unit Software Update (Panasonic)

## Applicability

| YEAR(S) | MODEL(S) | ADDITIONAL INFORMATION |
|---|---|---|
| 2014 | 4Runner, Highlander,<br>Sequoia, Tacoma,<br>Tundra | |

## Introduction

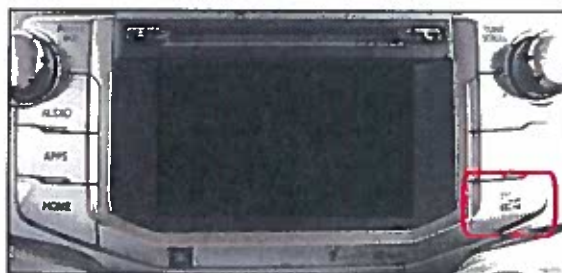
Figure 17.

If update fails and the error message "New software is not compatible with the system." displays, cycle the ignition OFF, remove the Map Micro SD Card from the head unit, and repeat steps 2 – 11.

Software update error is more likely to occur in areas with more traffic information.

Once update is complete, reinsert the Map Micro SD card into the head unit, cycle the ignition OFF, and proceed to step 13.
