# Entune Audio Head Unit Software Update (Panasonic)

Service Category Audio/Visual/Telematics

YEAR(S)	MODEL(S)	ADDITIONAL INFORMATION
2014	4Runner	
2014	Sequoia	
2014	Tacoma	
2014	Tundra

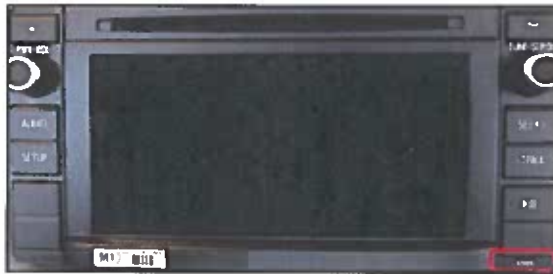
**Figure 1. Sequoia, Tacoma, & Tundra**

1. Confirm the audio system type by checking the Panel ID printed on the bottom-right or bottom-center of the machine.
