Entune Audio Head Unit Software Update (Panasonic)

YEAR(S)	MODEL(S)	ADDITIONAL INFORMATION
2014 – 2015	4Runner, Highlander, Highlander HV, Sequoia, Tacoma, Tundra

The information contained in this bulletin supersedes SB No. T-SB-0006-14.

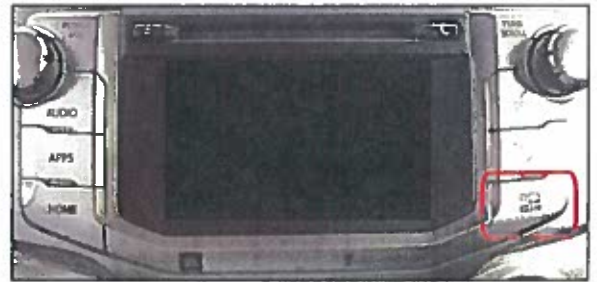
Figure 17.

Software update error is more likely to occur in areas with more traffic information.

If update fails and the error message "New software is not compatible with the system." displays, cycle the ignition OFF, remove the Map Micro SD Card from the head unit, and repeat steps 2 – 11.

Once update is complete, reinsert the Map Micro SD card into the head unit, cycle the ignition OFF, and proceed to step 13.
