Seat Heater Element Twisted/Bunched

Service Category Vehicle Interior

Section Seat

Some 2013 – 2014 model year Avalon and Avalon HV vehicles may exhibit a condition where the surface of the driver's seat bottom outer bolster is not even (has a ridge/bulge in it) or where the bottom outer edge of the driver's seat is uncomfortable.

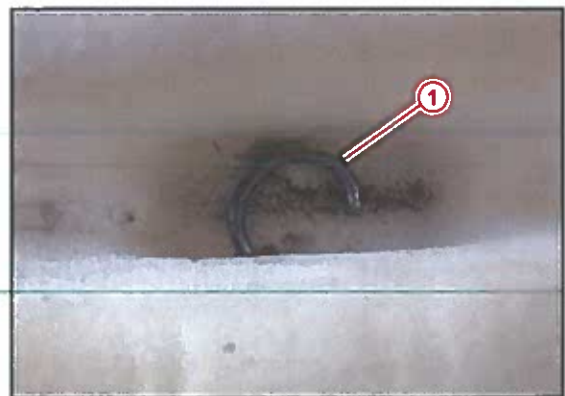
Figure 1.

1 Remove Clipped Hog Rings

CAUTION
To prevent seat damage and potential injury, ensure all the clipped Hog Rings are removed.

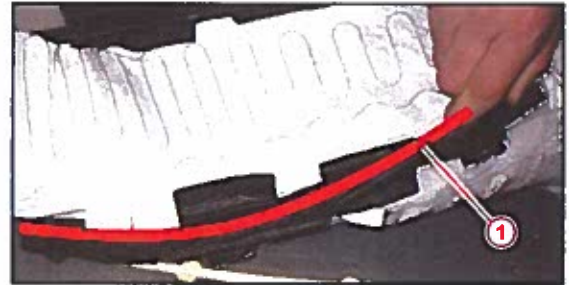
Figure 2.

1 Do NOT Bend Hog Ring Anchor Rod

While installing seat covers, do NOT bend the hog ring anchor rods.

Ensure all 22 tabs of seat heater element are attached to seat cover (NEW level parts have an additional two tabs).
