# 2014 Tundra/Tacoma Quality Confirmation Inspection

## Dealer Instructions

### 1. Intermediate Shaft N. 2 Inspection Procedure

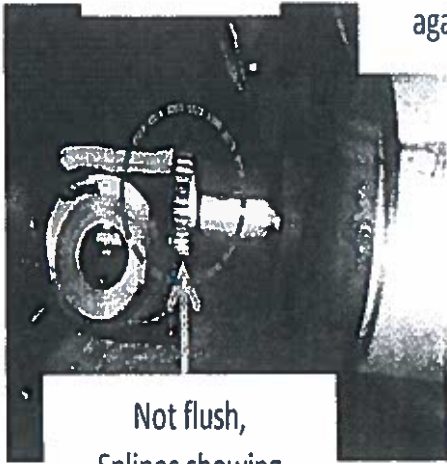
Tundra

Suspect Condition:

Splines showing,  
intermediate shaft no. 2 NOT flush  
against steering gear assembly.

A1: We are investigating the possibility that during the assembly process, the intermediate shaft no.2 may not have been completely engaged onto the splines of the steering gear.

If you find the intermediate shaft out of position, please continue to hold the vehicle and we will provide instructions on how to correct the concern prior to sale.

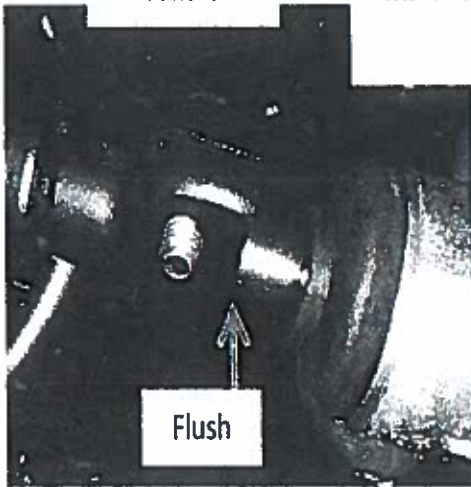
Tundra

OK Condition:

No splines showing, intermediate  
shaft no. 2 flush against steering  
gear assembly.
