Warm Air from HVAC Vents with A/C ON - DTC B1479

Service Category Vehicle Interior

YEAR(S)	MODEL(S)	ADDITIONAL INFORMATION
2010 – 2011	RX350

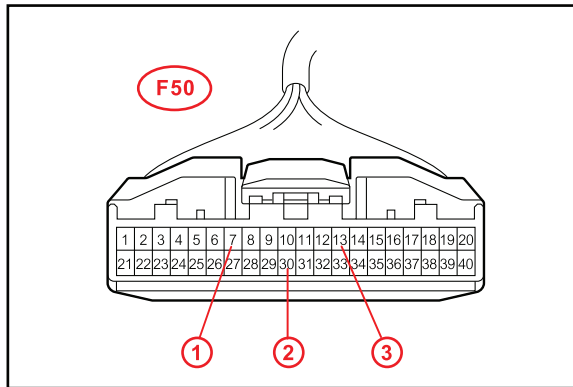
Figure 1. Front View of Wire Harness Connector (to A/C Amplifier)

1	FLOQ
2	S5-1
3	SG-2

TESTER CONNECTION	CONDITION	SPECIFIED CONDITION
F50-7 (FLOQ) - D10-3 (QUFL)	Always	Below 1 Ω
F50-13 (SG-2) - D10-2 (SGFL)	Always	Below 1 Ω
F50-30 (S5-1) - D10-1 (S5FL)	Always	Below 1 Ω
F50-7 (FLOQ) - Body Ground	Always	10 k Ω or Higher
F50-13 (SG-2) - Body Ground	Always	10 k Ω or Higher
F50-30 (S5-1) - Body Ground	Always	10 k Ω or Higher

- If any of the harness resistance tests fail, this bulletin does NOT apply. Repair or replace the harness and go to step 5.
- If all tests are within specifications, proceed to step 4.

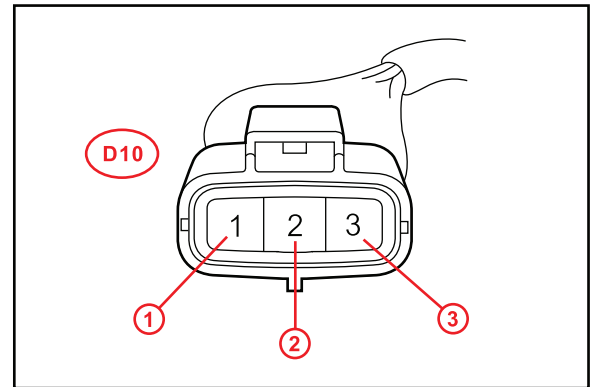
Figure 2. Front View of Wire Harness Connector (to A/C Compressor [A/C Mass Flow Sensor])

1	S5FL
2	SGFL
3	QUFL
