S-SB-0013-14

Hard Start, Rough Idle, Camshaft Sensor or Misfire DTCs

| YEAR(S) | MODEL(S) | ADDITIONAL INFORMATION |
|---|---|---|
| 2013 | FR-S | |

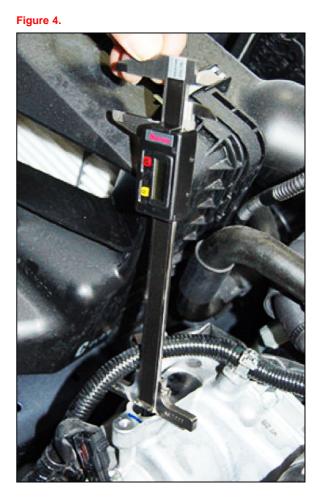
B. Using a breaker bar and 22 mm socket, place the socket on the crankshaft pulley bolt and rotate the engine clockwise approximately 70°. Keep in mind NOT to measure the notches as described in Figure 3.

C. Use the smallest of the 3 measurements and record the result.

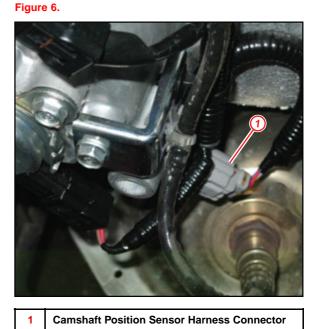
Use the following procedure if your DTC pertains to the exhaust side sensor.

- 1. Confirm DTC pertains to the exhaust side camshaft sensor (see DTC chart in the Inspection Procedure to determine which Shim Kit and O-ring to use).
- 2. Remove the applicable sensor from the timing cover and install a 0.2 mm thick shim from the applicable kit. If the DTC returns, use the next thicker shim (0.3 mm) and repeat as needed increasing the shim thickness 0.1 mm at a time.
