# Second Row Seat Squeak

YEAR(S)	MODEL(S)	ADDITIONAL INFORMATION
2010 – 2013	4Runner

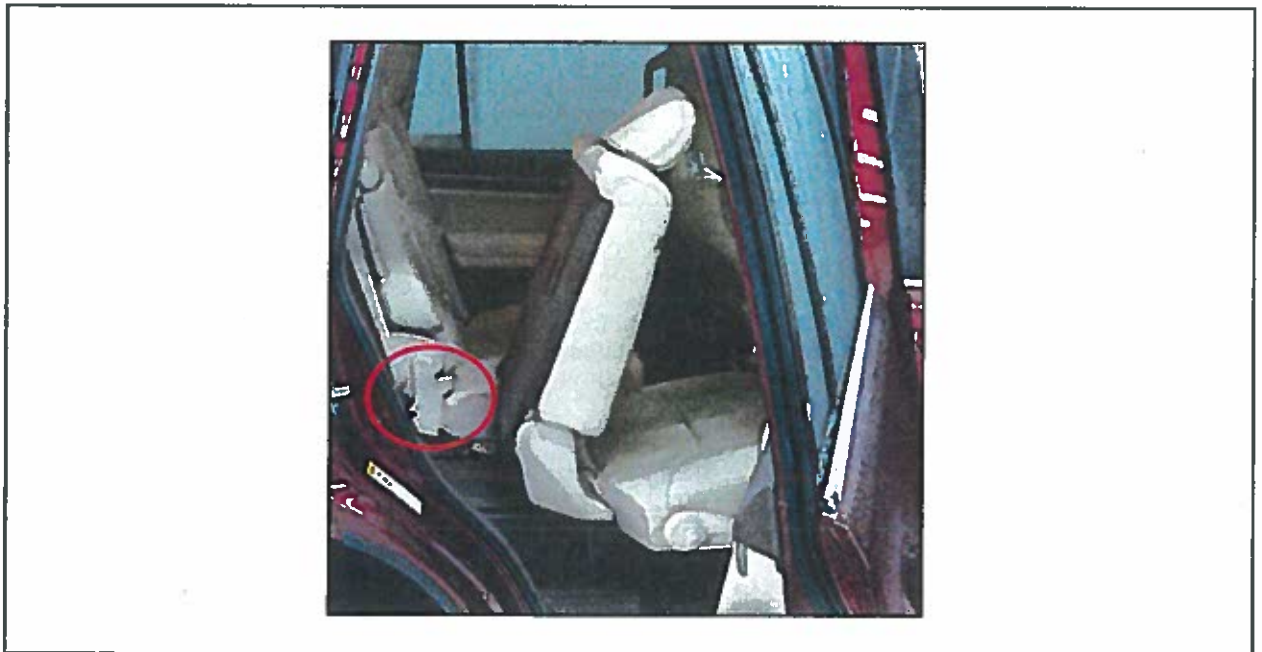
Some 2010 – 2013 model year 4Runner vehicles may exhibit a squeak noise coming from the second row seats when driving over uneven terrain.

The bracket for the inside hinge of the 60% second row seat may rub the seat frame. Follow the procedure outlined below to address this condition.

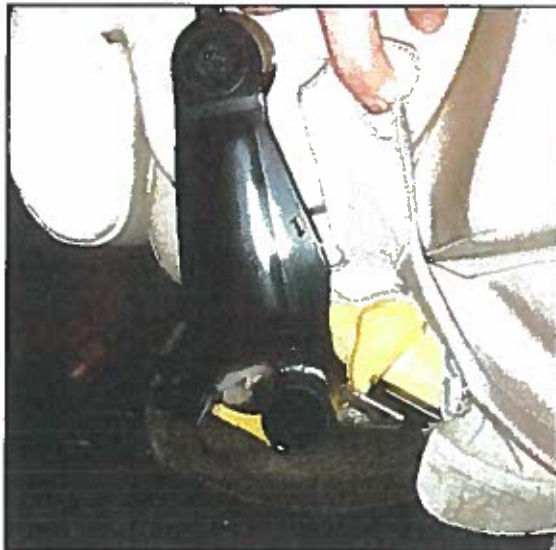
**Figure 2. Approximate Vantage Point (Reposition Foam to Access View)**

3. Confirm that a noise is being generated by two surfaces rubbing, as shown below.
