# Second Row Seat Squeak

YEAR(S)	MODEL(S)	ADDITIONAL INFORMATION
2010 – 2013	GX460

Some 2010 – 2013 model year GX 460 vehicles may exhibit a squeak noise coming from the second row seats when driving over uneven terrain.

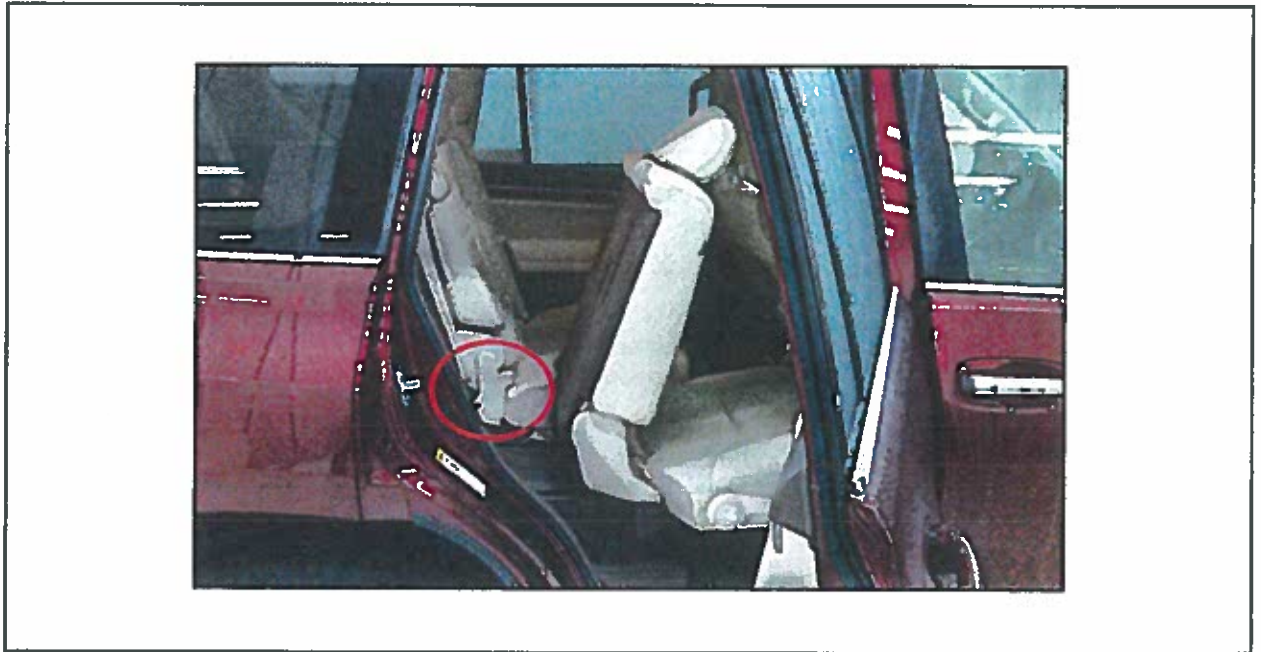
The bracket for the inside hinge of the 60% second row seat may rub the seat frame. Follow the procedure outlined below to address this condition.

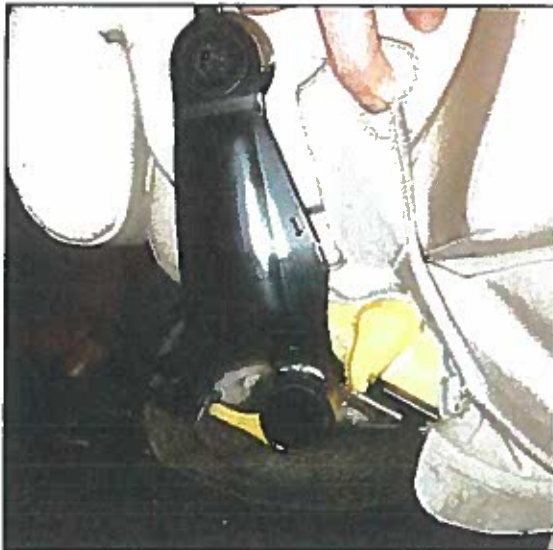
**Figure 2. Approximate Vantage Point (Reposition Foam to Access View)**

3. Confirm that a noise is being generated by two surfaces rubbing, as shown below.
