**Best practices when performing TSIB L-SB-0008-12**

2010-2014 LS460 FSPORT

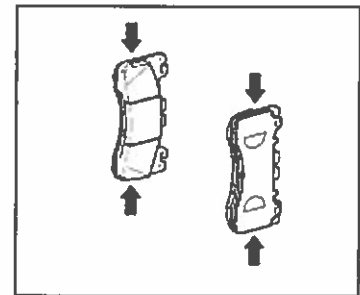
Application point of grease

1. Do NOT polish and/or grind the brake disc.  
Also, do not replace the brake disc unless the disc thickness is less than 33.0 mm (1.30 in.).
2. Grease is included with the front disc brake pad kit. Apply a light coat of disc brake grease to the edges of the brake pads as shown in the illustration. Additionally, ensure there is no oil and/or grease on the friction surfaces of the pads and the disc.
3. Make sure the single slotted pad is installed on the inside location of the brake disc.
4. Perform all repairs following the TSIB L-SB-0008-12 or repair manual. Disregard the replacement instructions that are included with the front disc brake pad kit by the brake pad kit supplier.
