# Service Bulletin

Bulletin No.: PI1162B

**Subject:** Mobile Telephone Microphone Poor Performance when Using Bluetooth

**Models:** 2013-2014 Cadillac ATS  
2014 Cadillac CTS Sedan  
All Built Prior to October 18, 2013

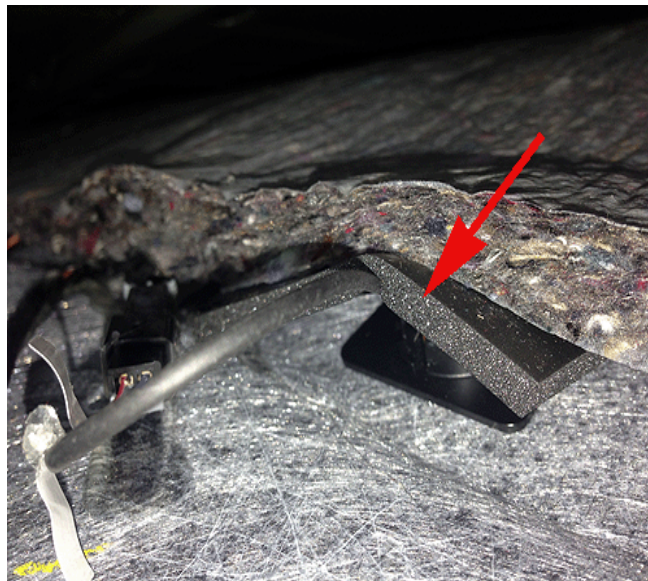
3541395

The foam patch on the back of the headliner at the microphone mounting area may have come loose. This foam is a sound barrier for the back side of the microphone. If the patch is detached, it allows unwanted noise to interfere with the microphone operation when making a phone call.

Use the following steps to install a larger foam rubber patch to the microphone area and reattach any loose wire harnesses to the headliner.
