Service Bulletin

Bulletin No.: P11221

Subject: Excessive Wind Noise from Front Side Door Glass Area

Models: 2014 Chevrolet Silverado 1500
2014 GMC Sierra 1500

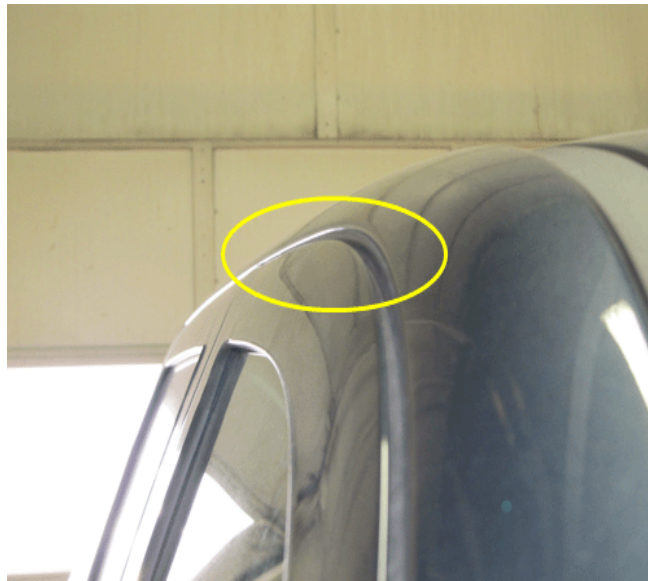
3806381

Improper Front Side Door Fit to Roof (Recommendation 1)

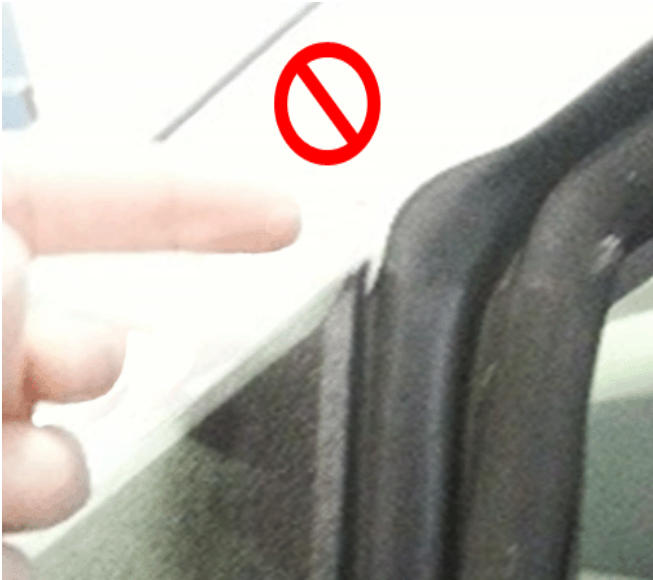
3814708

Incorrectly Installed Front Door Glass Run Channel Weatherstrip in the Front Upper Corner at Mirror (Recommendation 2)

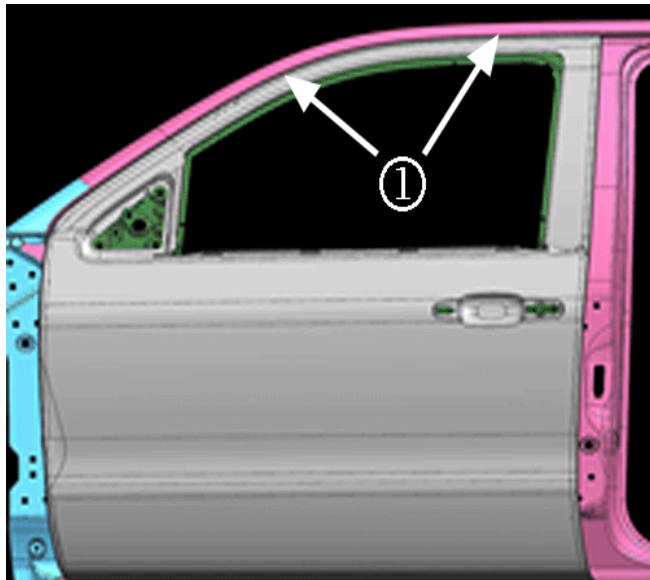
3806385

Note: The 2014 Silverado/Sierra uses an inlay door construction with the door fitting sub-flush to the body header by 1-2 mm (0.40–0.80 in).

1. At the two locations (1) shown in the illustration above, check the front door fit as to meeting the suggested 1-2 mm (0.40–0.80 in) sub-flush dimension.

2. **In conditions where the door header is outboard the design intent,** a 1-2 mm (0.40–0.80 in) change may be accomplished by bending the door header inboard.
 - 2.1. Lower the front side door glass.
 - 2.2. Placing one hand at the belt and the other at the door header, carefully attempt to bend the door about the belt.
 - 2.3. Recheck the door fit to the body header.

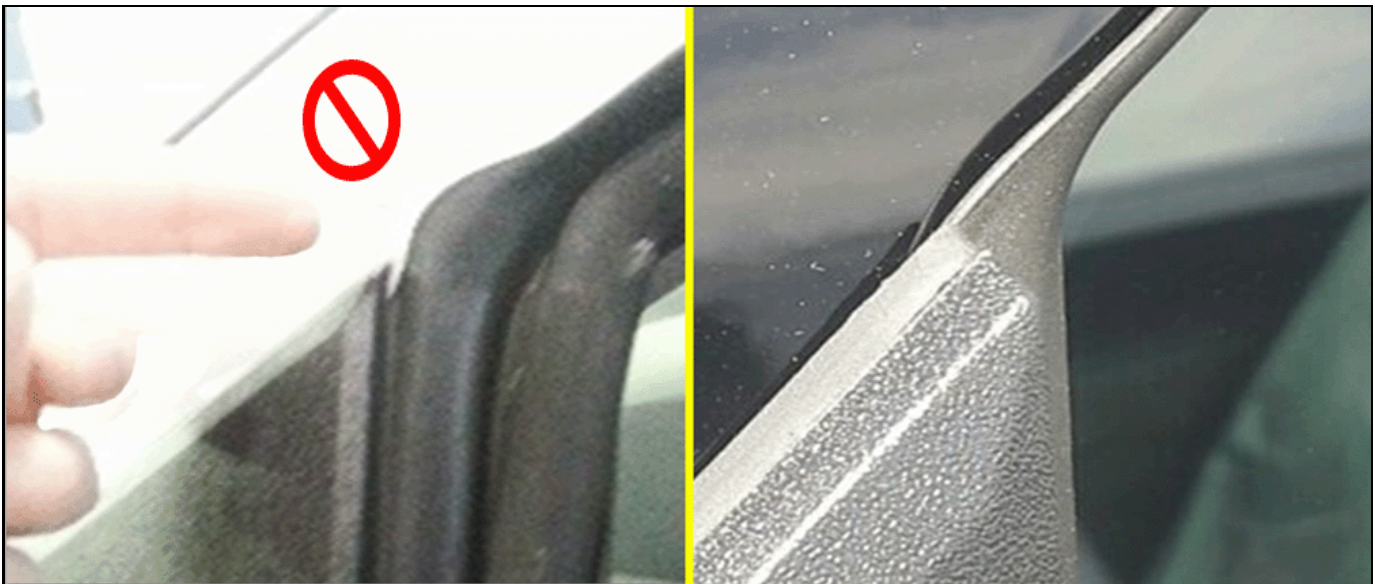
3814718

Note: The graphic above shows an example of incorrect and correct position of the window weatherstrip tucked behind the rearview mirror gasket molding. If the weatherstrip is not retained by the mirror gasket molding, it will open up creating the air leak while driving.

Loosen and reinstall the header portion of the front door glass run channel weatherstrip following the steps below:
