# Service Bulletin

Bulletin No.: 02-08-42-001G

**Subject:** Headlamp, Tail Lamp, License Lamp or Fog/Driving Lamp Damage

**Models:** 2015 and Prior GM Passenger Cars and Trucks

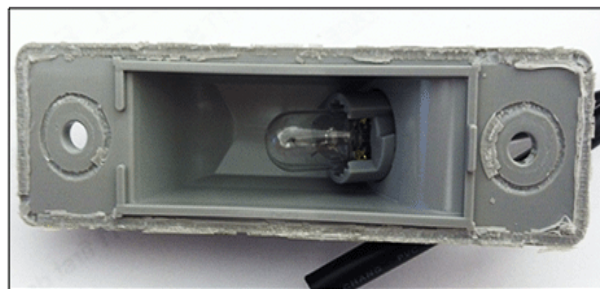
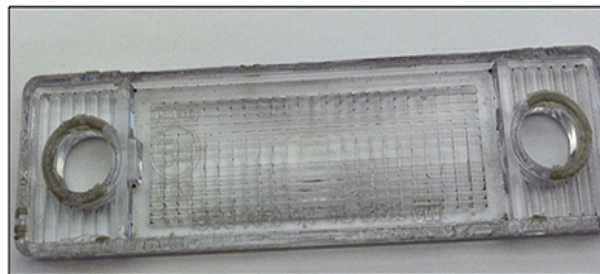
2770495

- The license lamp above exhibits a separation of the bond of the lens and housing, and a clouding of the polycarbonate lens. This condition was the result of applying chrome cleaner to the rear bumper and license lamp.

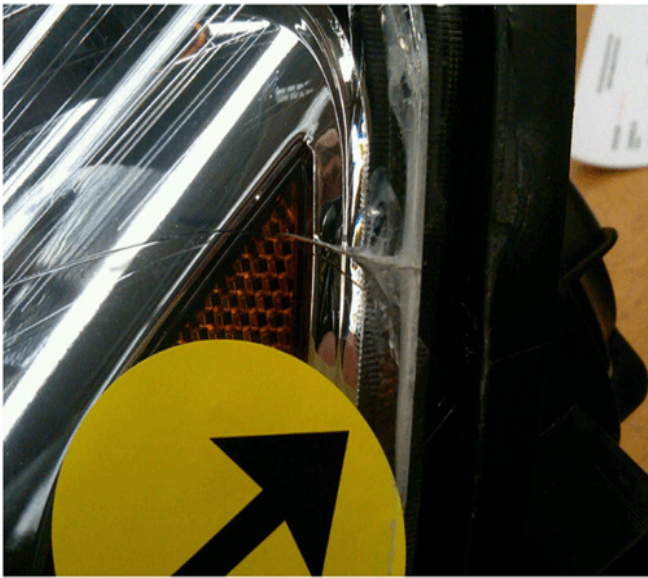
2650225

- This lamp shows some effects of chemical damage. Notice the milky color along the edge and the fracture. This was caused by a solvent used to prep the body for pin striping.

**Warning:** Use only lukewarm or cold water, a soft cloth and a car washing soap to clean exterior lamps and lenses.

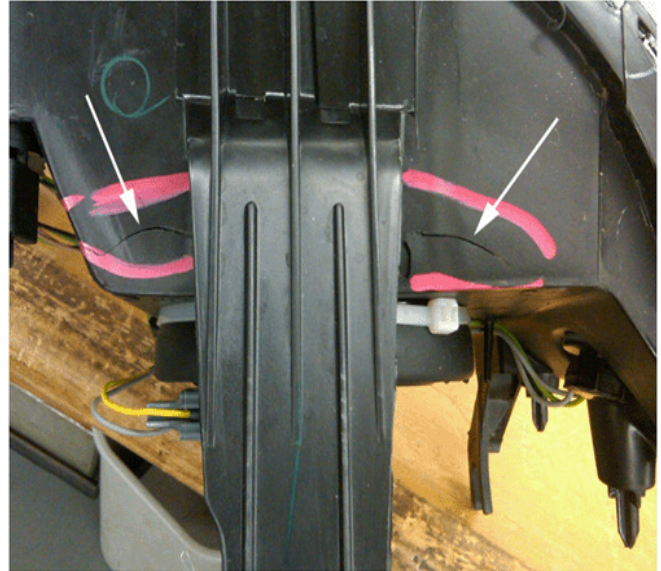
2650230

This housing is cracked across the top of the housing just below the mounting tab. Not shown is the dent at the upper edge of the lens where it impacted an object.

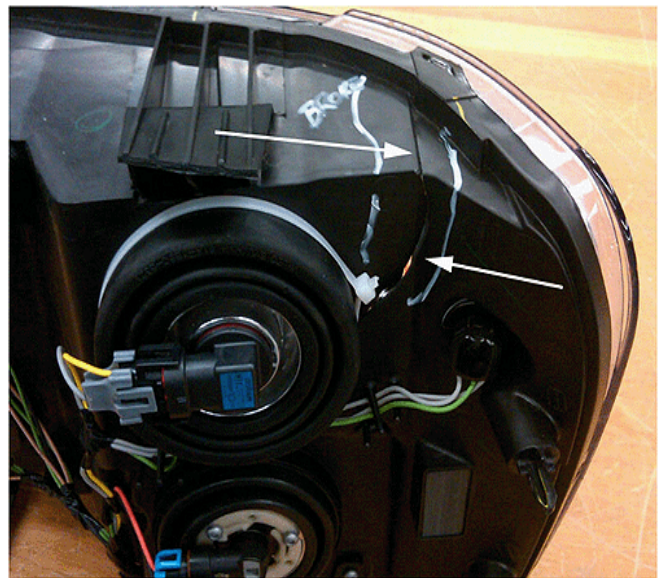
2650242

This housing shows a broken upper mounting tab and a fracture in the rear housing. This lamp had no visible marks on the lens.

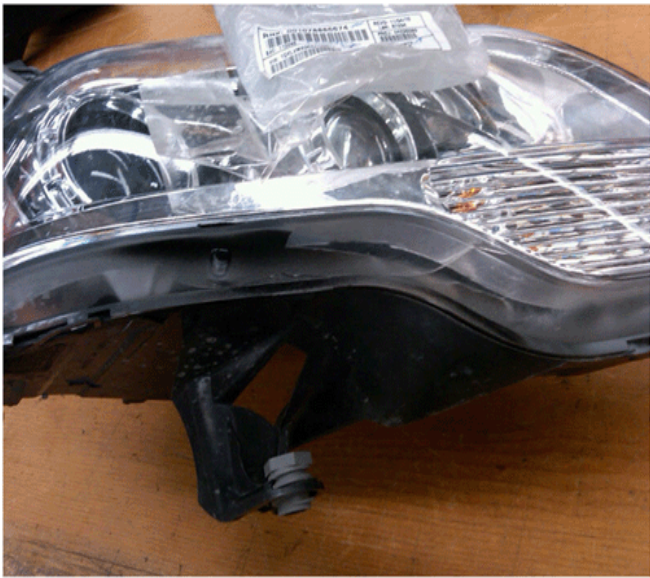
2650250

This lamp shows paint over spray along the lower edge where it would marry to the front fascia. The lower mounting tabs were also all fractured at the housing due to impact.

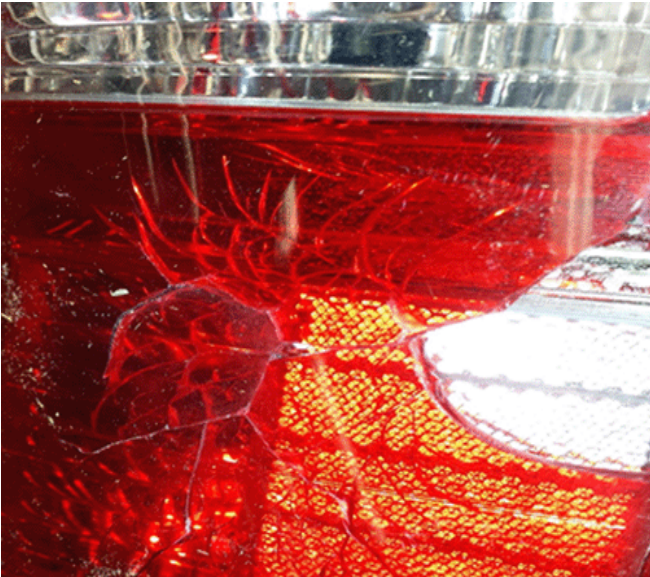
3806648

This lamp shows impact damage and internal cracking of the lens.

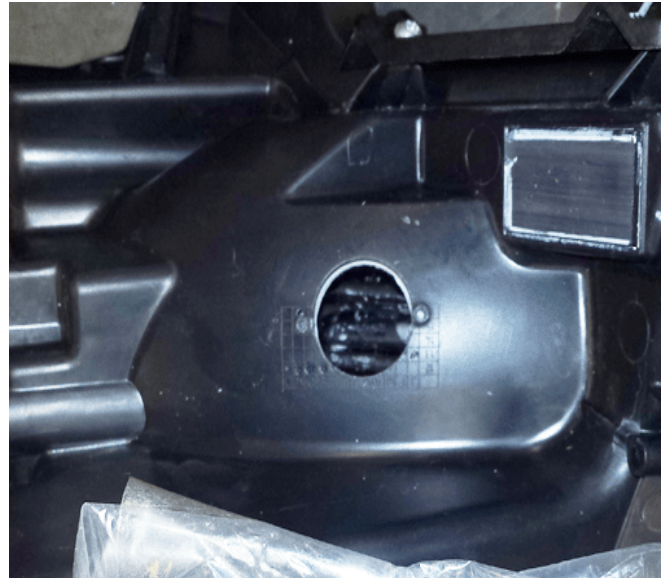
3806649

This housing shows a hole which was drilled in the lamp to accept an accessory modification.

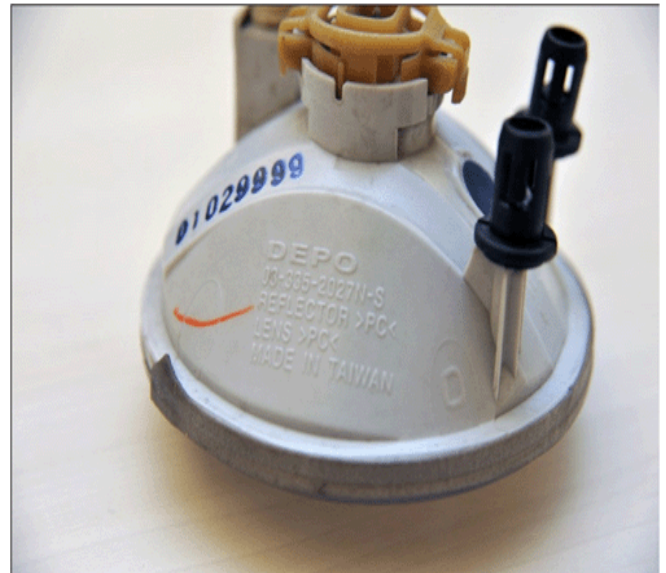
2650251

This fog lamp was returned for retaining moisture. As you can see it is marked with the Depo brand (it is also called out on the front lens).

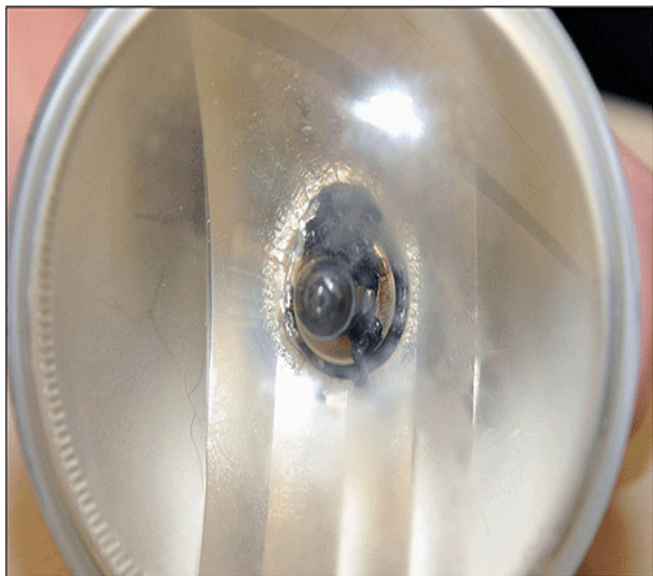
2650252

Another trend being seen is the installation of bulbs that have a higher output than the original equipment. Because the bulb output is higher, the operating temperature is also higher. This excessive heat can melt the socket, housing, or lens. Because these bulbs burn hotter and brighter, they also have a reduced service life. These bulbs are different in appearance than the original equipment. Some have blue tint on the bulb and others are clear. If in doubt, the bulb number should match the GM service part.
