Bulletin No.: PI1225

PRELIMINARY INFORMATION

Subject: Rattle and/or Squeak from Front Passenger Compartment, Instrument Panel or

Models: 2013-2014 Cadillac ATS

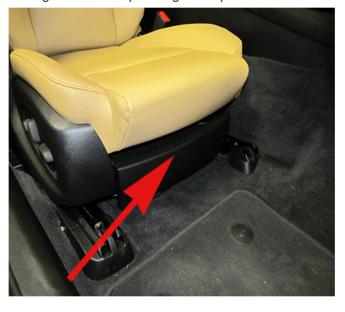
3814680

Some customers may comment there is a rattle and/or squeak noise coming from the dash or front seat area. This condition may be on the left and/or right side of the passenger compartment.

This condition may be caused by the plastic finish panel on the front of the seat. This sound may reflect off of the instrument panel, creating the perception that it is coming from the instrument panel area.
