# Service Bulletin

Bulletin No.: PI0924B

**Subject:** Intermittent Unwanted Trunk Opening While Vehicle is Parked

**Models:** 2010-2014 Buick LaCrosse  
2011-2014 Buick Regal  
2012-2014 Buick Verano  
2011-2013 Chevrolet Cruze  
2012-2013 Chevrolet Sonic (4 Door Sedan Only)  
2013-2014 Chevrolet Malibu

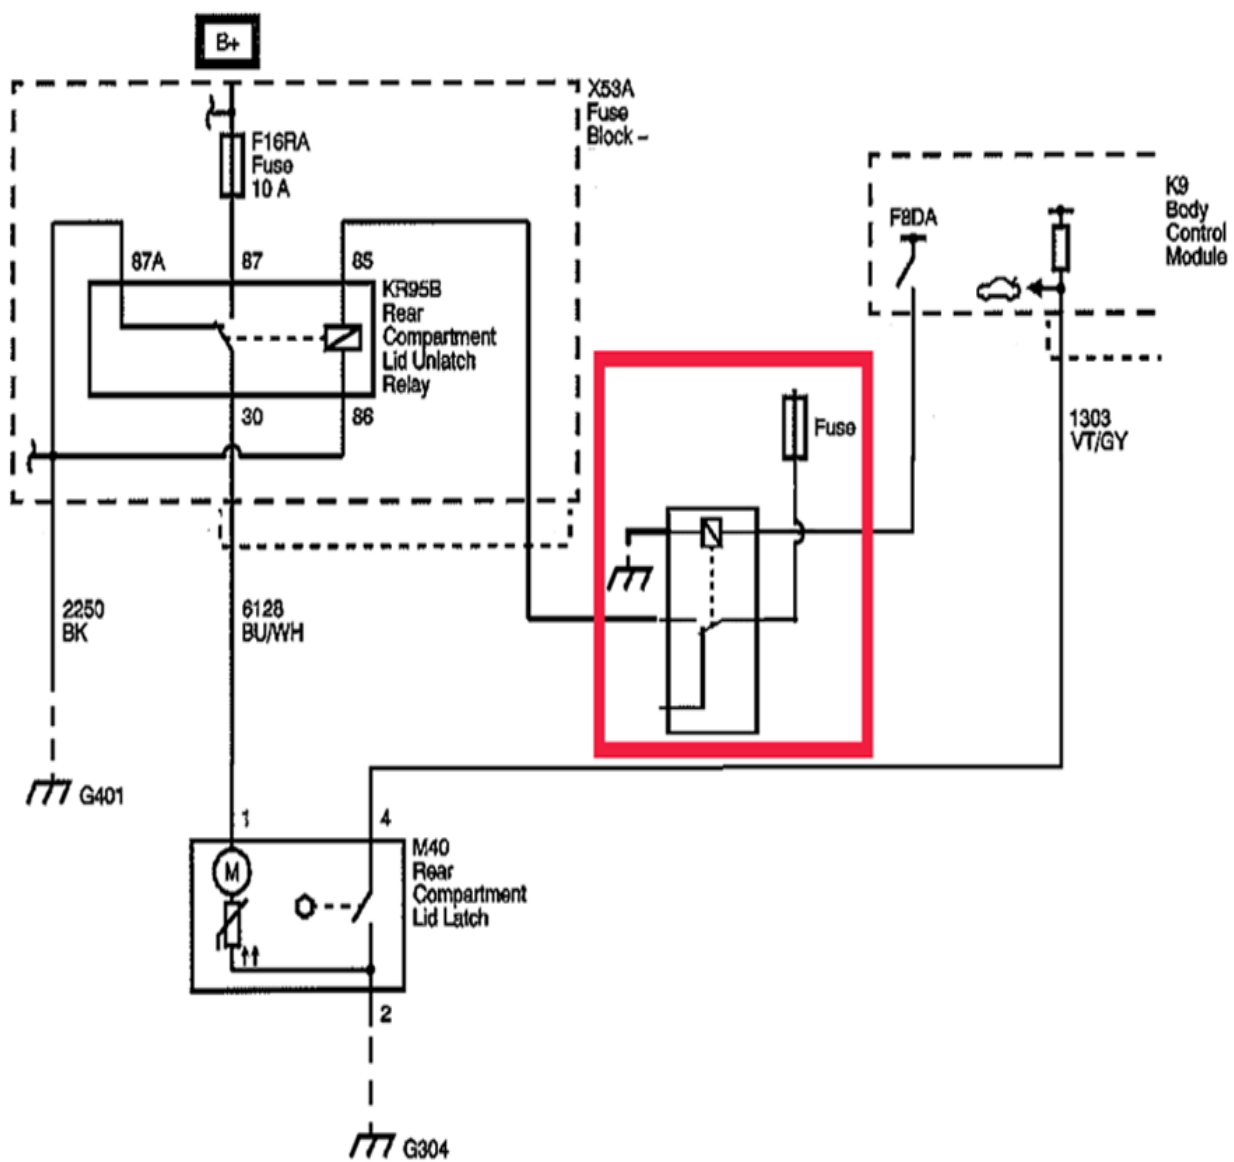
3329904

The rear compartment lid unlatch relay is part of the printed circuit board in the relay/fuse block and not serviceable separately. Installation of an external relay circuit to bypass the feed to the trunk release control will be required. Install the "Two Shot Relay" adjacent to the BCM and attach a tag to the relay and mark with "Two Shot Trunk Relay per Bulletin PI0924." For future diagnosis for an inoperative trunk release, this relay installation will be identified before a BCM is replaced.

1. Label the four leads of connector, P/N 12126045 as indicated below.
2. Connect the connector to the new relay, P/N 19119267.
3. Locate circuit 6188 (trunk release control) at the BCM following service information. Cut the wire and splice the BCM and relay side of the circuit as shown below.
4. Connect wire fused, unswitched power and ground as shown below.
