Bulletin No.: PI1228

PRELIMINARY INFORMATION

Subject: Diagnostic Tips for Malfunction Indicator Lamp (MIL) On, Charging System Light On,

Models: 2012-2014 Buick LaCrosse, Regal

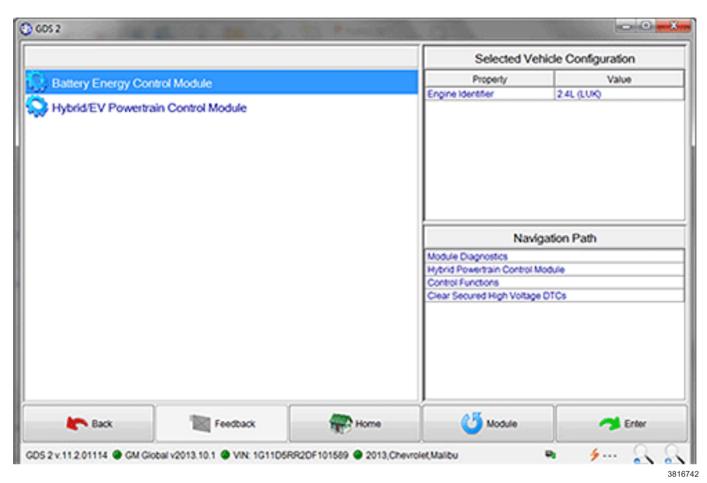
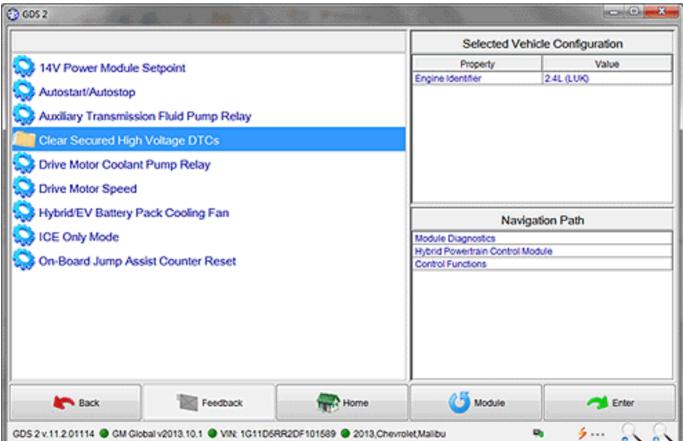
DTC P1A01, P1A5C, P0AFA, P1EAC or U180B can falsely set following a loss of 12V power or due to low 12V conditions.

If published diagnostics lead to the replacement of the Battery Energy Control Module (BECM), DO NOT replace the BECM without first clearing the codes and verifying if they reset. The codes must be cleared within the Battery Energy Control Module by selecting "Clear Secured High Voltage DTCs" as shown below. After clearing the codes, the ignition will need to be turned off for a minimum of two minutes. If the code returns after a successful clear, then replace the Battery Energy Control Module (BECM).

Important: After installation, the BECM must be programmed with SPS.
