# Service Bulletin

Bulletin No.: 08-08-57-003D

**Subject:** Floor Wet Under Carpet/Engine Continues to Run with Key Off/Possible No Crank/No Start/Communication Loss/Various Electrical Concerns (Seal Seam)

**Models:** 2008-2012 Buick Enclave  
2009-2012 Chevrolet Traverse  
2007-2012 GMC Acadia  
2007-2010 Saturn OUTLOOK

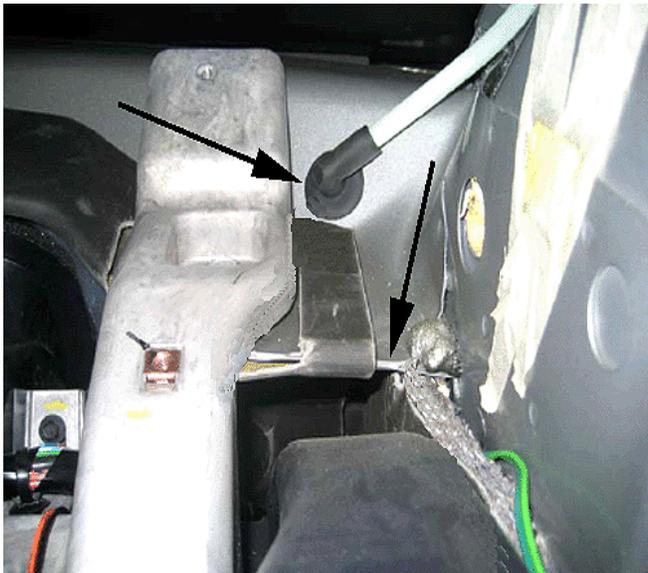
2125552

Water from the right front sunroof drain hose exits the vehicle through the plenum (upper arrow) and may re-enter through the un-sealed seam at the front of the dash. Refer to lower arrow in the illustration.

In more current model years, sunroof drain hose and windshield related issues have sometimes been found to be a source of a water leak in the A-pillar area. This water can also sometimes leak on the IP BEC and/or onto the floor area.
