# Service Bulletin

**Subject:** Spark EV (BEV) 1ET35 Drive Unit Exchange Program

**Models:** 2014 - 2015 Chevrolet Spark EV (BEV)  
Equipped with 1ET35 Transaxle (RPO MME)

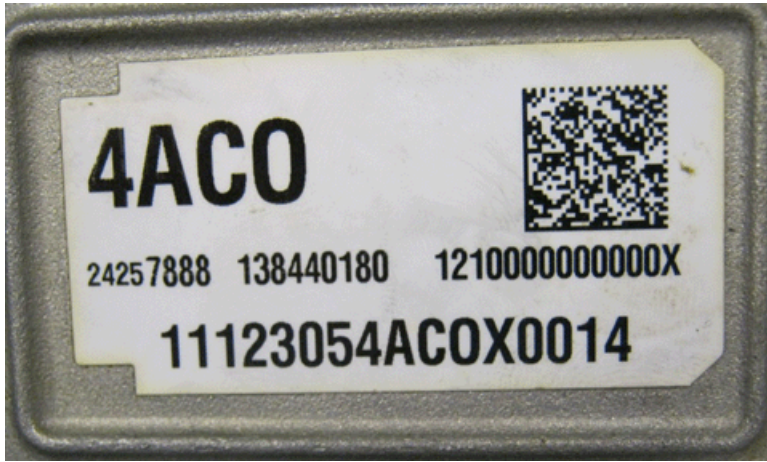
The Drive Unit Tag Number must be supplied to TAC when calling for a Drive Unit exchange.

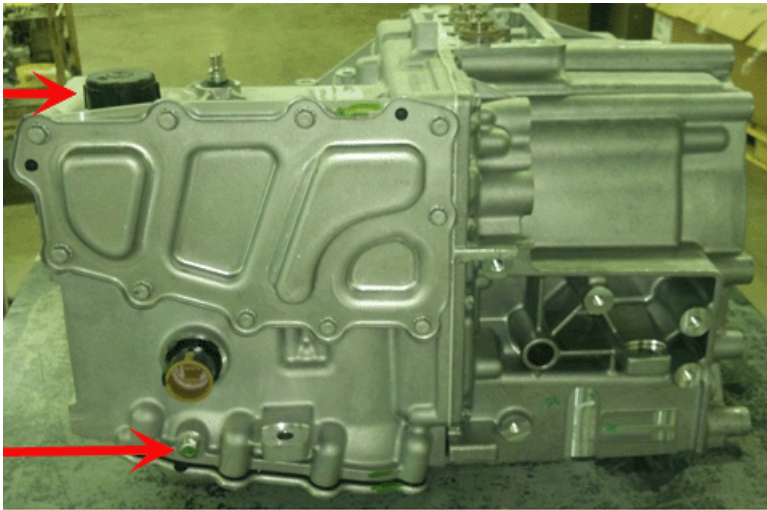
The Drive Unit fluid level and condition check procedure includes the steps to check the Drive Unit fluid level, as well as the conditions of the fluid. The 1ET35 Drive Unit is not equipped with a fill tube or dipstick. Therefore, a fill cap in the top of the Drive Unit (see top arrow) and level set plug (see lower arrow) sets the fluid level.

1. Operate vehicle until Drive Unit fluid temperature is 30–50°C (86–122°F).
2. Raise the vehicle.
3. Remove the front compartment air deflector.
4. Place the Drive Unit in Park.
5. With the scan tool, command the auxiliary Drive Unit Fluid Pump speed to ON for 10 minutes.
6. Remove the Drive Unit case level set plug.
7. Verify fluid slowly drips from the hole that the case level set plug was removed from.
  - a. If the fluid is flowing as a steady stream, wait until the fluid begins to drip from the case level set plug hole.
  - b. If no fluid comes out, add .5 L (.52 Qts.) of fluid until fluid drips out of the case level set plug hole.
8. Install Drive Unit case level set plug and torque to 12 Y (106 lb. in).
9. Turn off the vehicle.
10. Install the front compartment air deflector.
