Service Bulletin

PRELIMINARY INFORMATION

Subject: 2014 Chevrolet Cruze Diesel P0133 And Or P22FA

Models: 2014 Chevrolet Cruze
Equipped with the 2.0L (RPO-LUZ) 4-cyl Diesel Engine

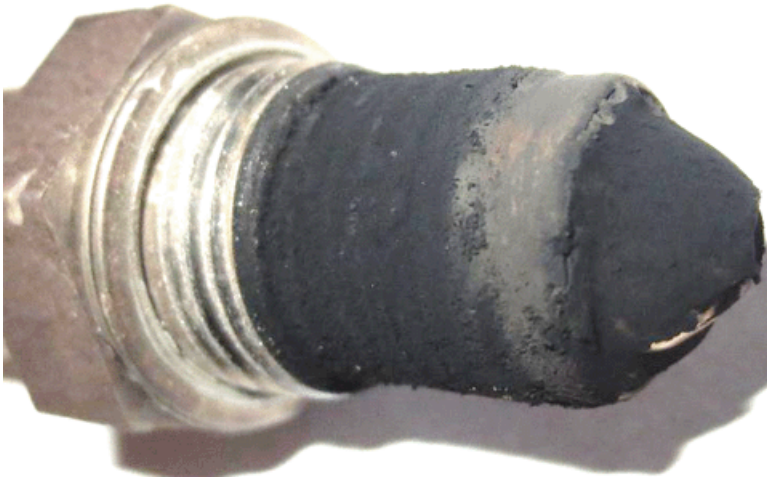
If DTCs P0133 or P22FA are found, remove and inspect the Heated Oxygen Sensor (HO2S) and the NOx Sensor 1 (NOx1) for soot build up.

Soot Covered HO2S

If found to be covered with soot, replace both sensors and continue with the remaining steps of this PI.

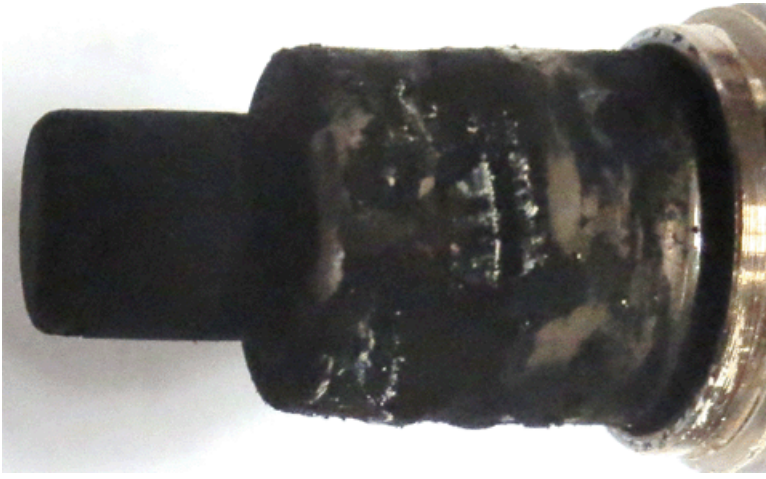
Soot Covered NOx 1 Sensor
