## Creaking/squeaking on front axle suspension strut

| Topic number | LI32.20-P-059959 |
| Design group | 32.20 Steel springs/torsion bars, Niveaumat |
| Validity | MODEL 205 without CODE 489 |

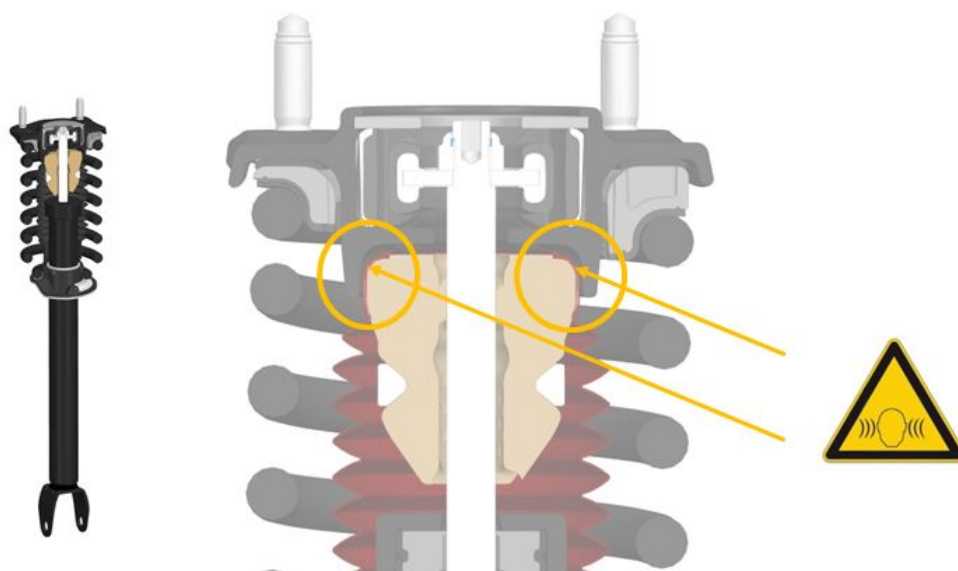
1\_Geräusch Knarzen.  
JPG:

When the suspension strut experiences strong deflection, the enlarging of the stop buffer causes the boot to come into contact with the head bearing's cup housing (noise may be generated in combination with relative movements between the boot and the cup).

| Attachments | |
|---|---|
| 1_Geräusch Knarzen.JPG | Cause and remedy (Lubrication area for grease) |

1. Raise vehicle at front axle.
2. Pull down stop buffer with boot.
3. Apply light coating of grease to boot in area between head bearing cup, see attachment: "Cause and remedy (Lubrication area for grease)".
4. Push stop buffer with boot back up to original position.
5. Lower vehicle.

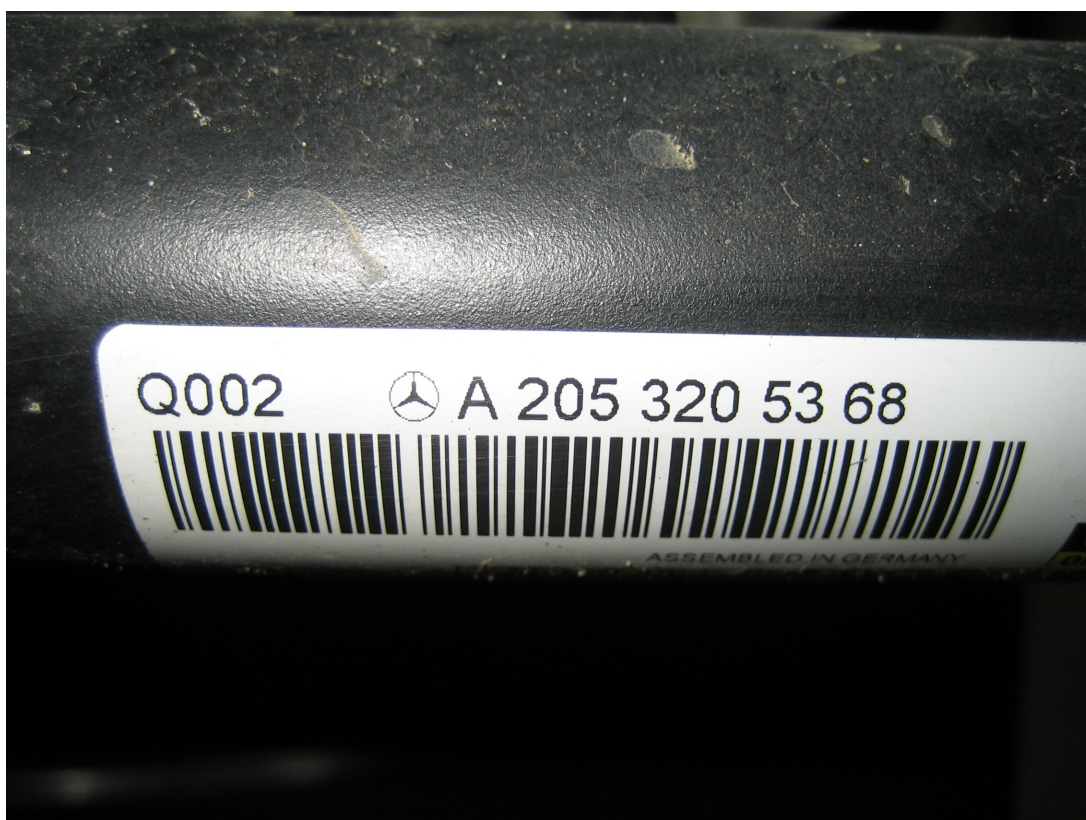
Label\_1\_Federbein\_205.  
JPG:

| File | Description |
|---|---|
| Label_1_Federbein_205.JPG | Photo of suspension strut label no. 1 |

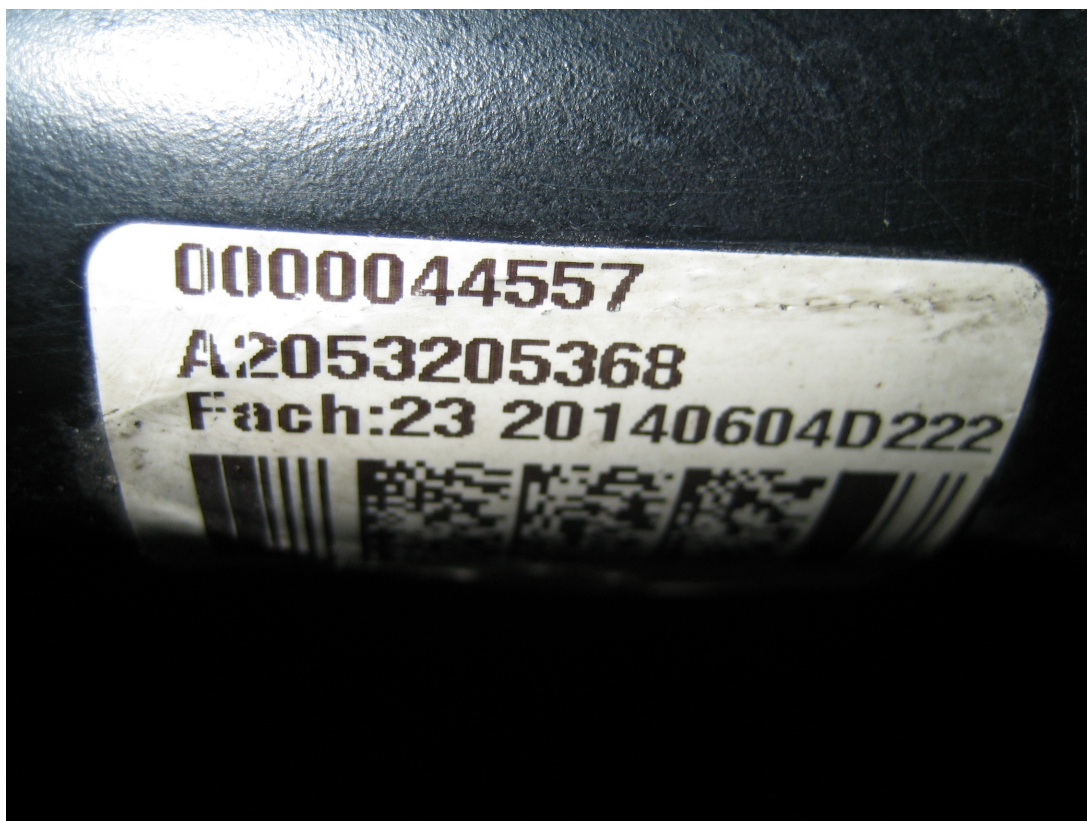
Label\_2\_Federbein\_205.  
JPG:

| File | Description |
|---|---|
| Label_2_Federbein_205.JPG | Photo of suspension strut label no. 2 |
