## Cover of storage slot at front under roof liner (FF8) not fitting.

| Topic number | LI68.30-N-059117 |
| Validity | Model 906 with CODE FF8 (1 DIN slot at front under headliner) |

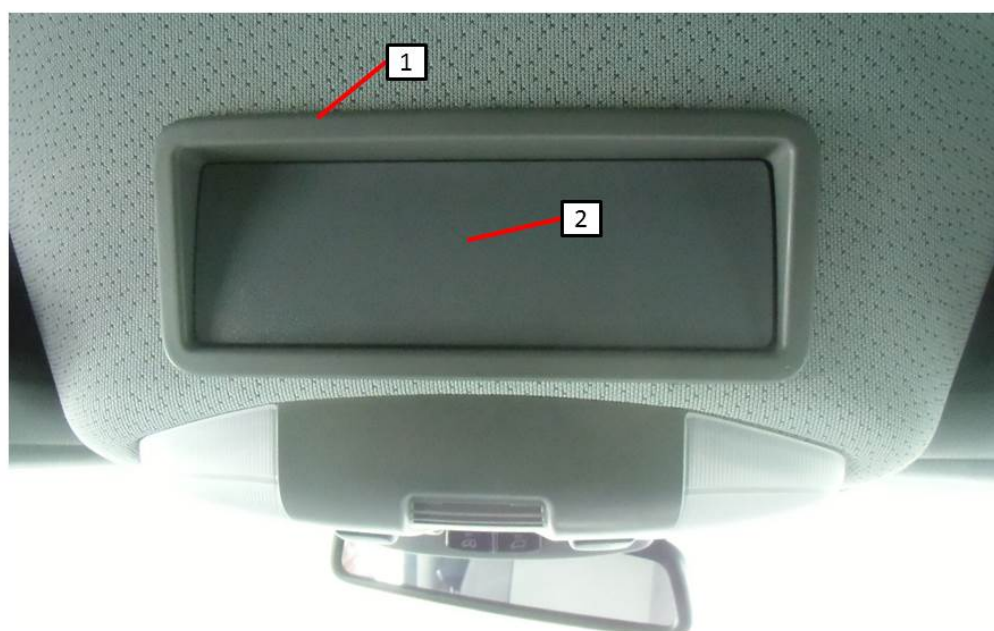
01.jpg:

Cover (1) of storage slot at front under roof liner (FF8) not fitting.

Minimum dimensions of the cutout in roof liner is too large leading to an insufficient overlap by the cover (1) (A 906 695 0130).

| Attachments | |
|---|---|
| 01.jpg | 1 DIN slot |

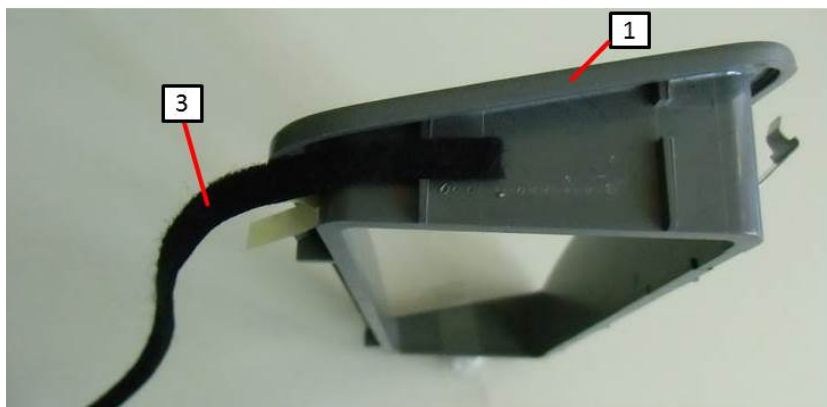
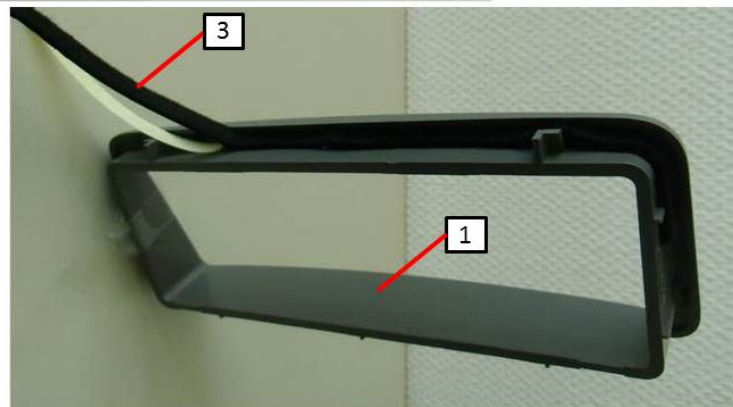
02.jpg:

| Attachments | |
|---|---|
| 02.jpg | Positioning of felt strip (3) |

1. Remove cover (2) or installed electrical equipment
2. Remove carrier
3. Unclip cover (1)
4. Cut felt strip (3) to size (dimensions: 240mm x 5mm)
5. Stick felt strip (3) onto bottom of cover (1) (see Figure 02 and Figure 03)
6. Assemble in the reverse order

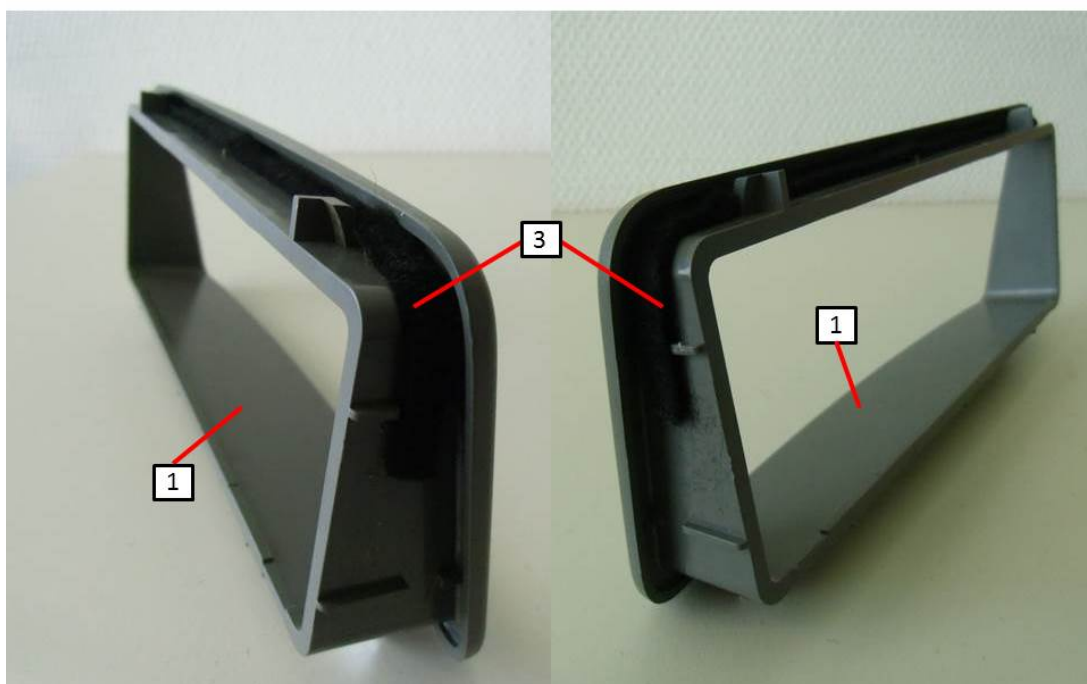
03.jpg:

| Attachments | |
|---|---|
| 03.jpg | Felt strip (3) attached |
