## Fit of bumper to left/right side wall

| Topic number | LI88.20-P-060095 |
| Validity | Model series W/S 205 |

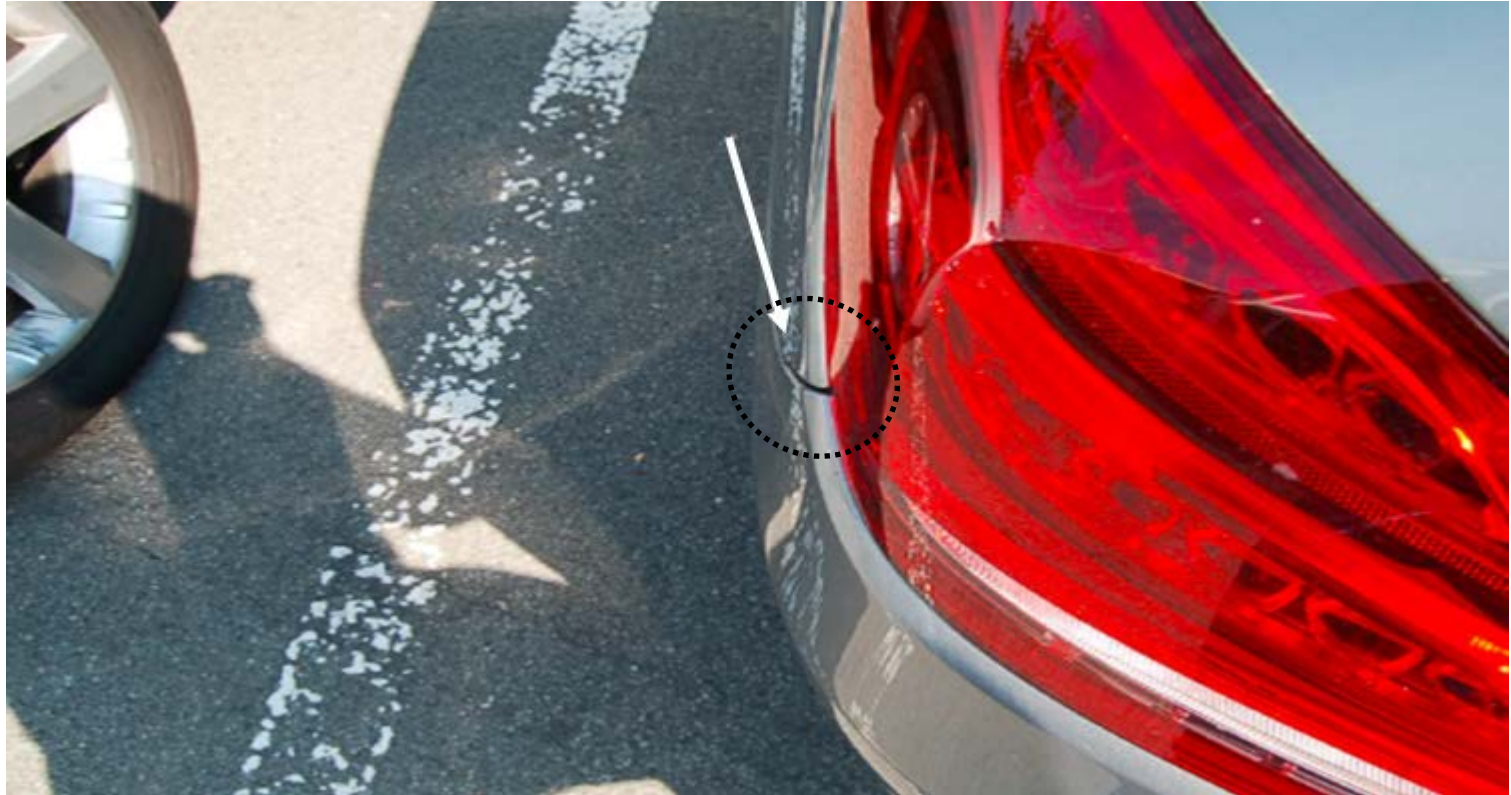
# Bumper Protrusion

- Protrusion of bumper relative to fender.
- Gaps between bumper and fender too large in area of rear lamp.

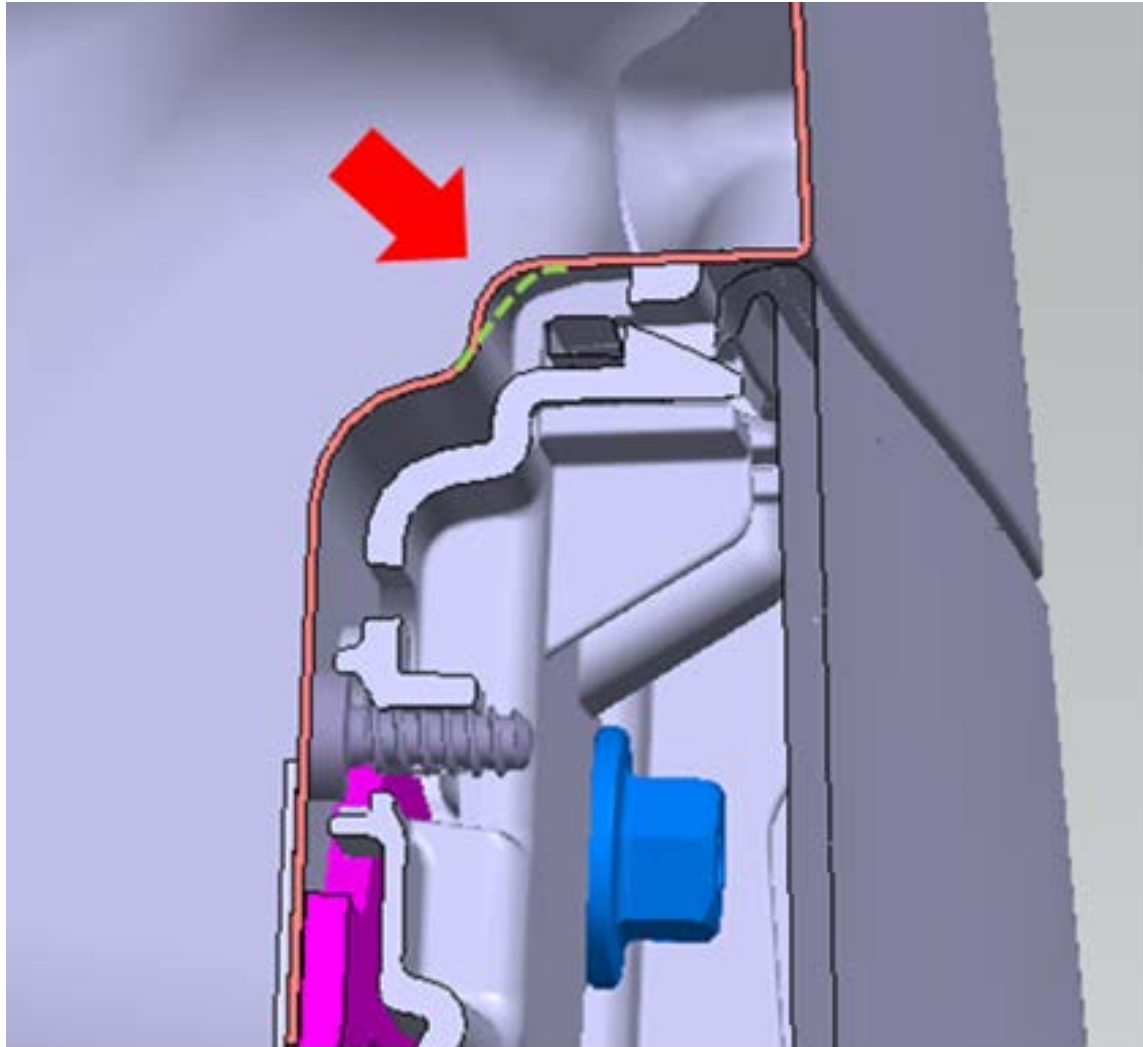
# Lower fender to bumper mount radius

Due to a very tight radius on the lower part of the side wall, the guide rail may be incorrectly positioned. (see attachment "side wall radius")
