Model series 246/176/117 center stowa- ge compartment closes/opens with difficulty

Topic number	LI68.20-P-058749
Version	2
Design group	68.20 Center console
Date	10-29-2014
Validity	Model series 246/176/117 up to production date 30.6.2013 only with automatic transmission (code 429)
Reason for change	B Class added
Reason for block

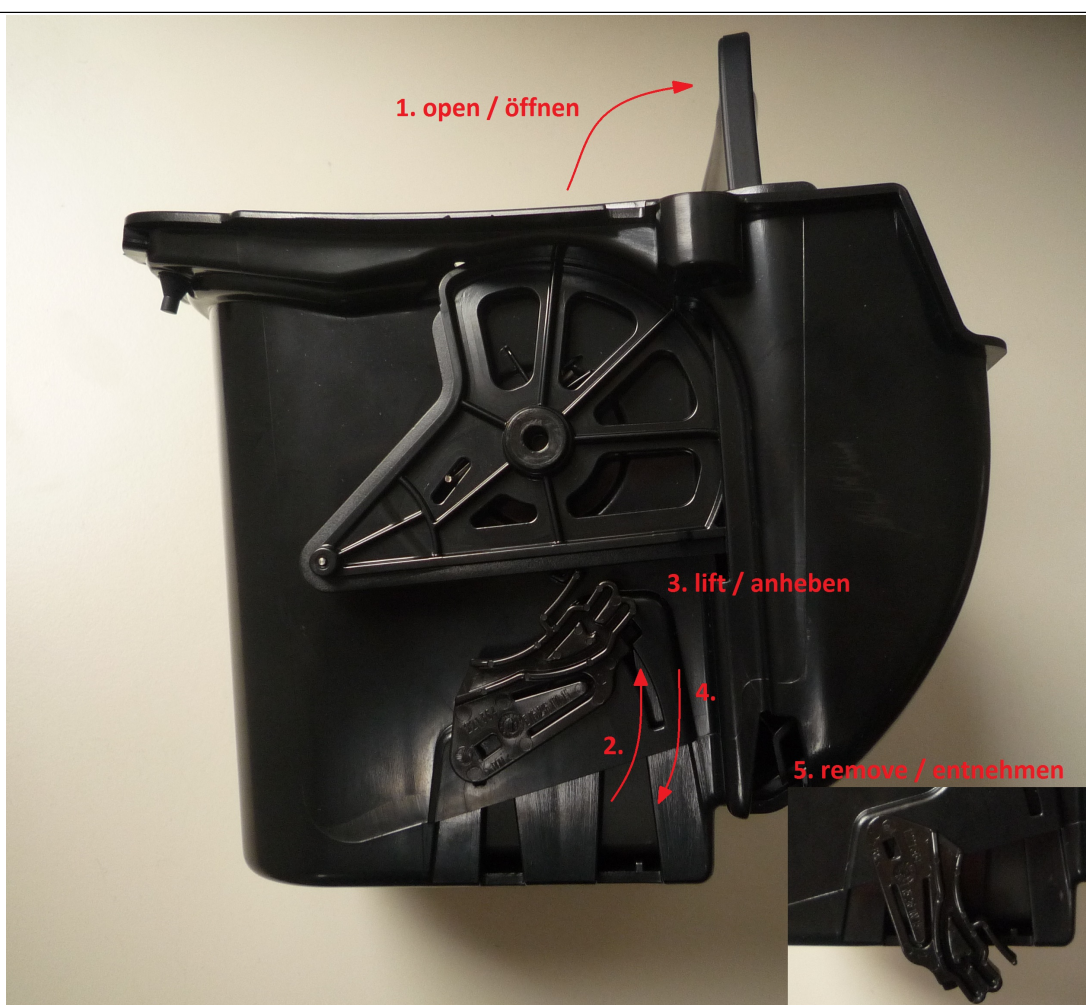
Ausbau Betätigungshebel - Führungsschiene
A176 766 00 00.jpg:

The center stowage compartment does not open or close smoothly.

The guide rail for the lid jams.

Replace operating lever/ guide rail:
 Remove stowage compartment (AR.6820-P-2420NKB)
 Remove operating lever/ guide rail at side (see picture).
 Install new operating lever/ guide rail (A176 766 00 00 or A246 766 00 00) in the reverse order.
