Service Campaign Bulletin

Campaign No 2014040004, May 2014

SUBJECT: **Model 207 (E-Cabriolet), Model Year 2014**
Check Seam Seal at Trunk

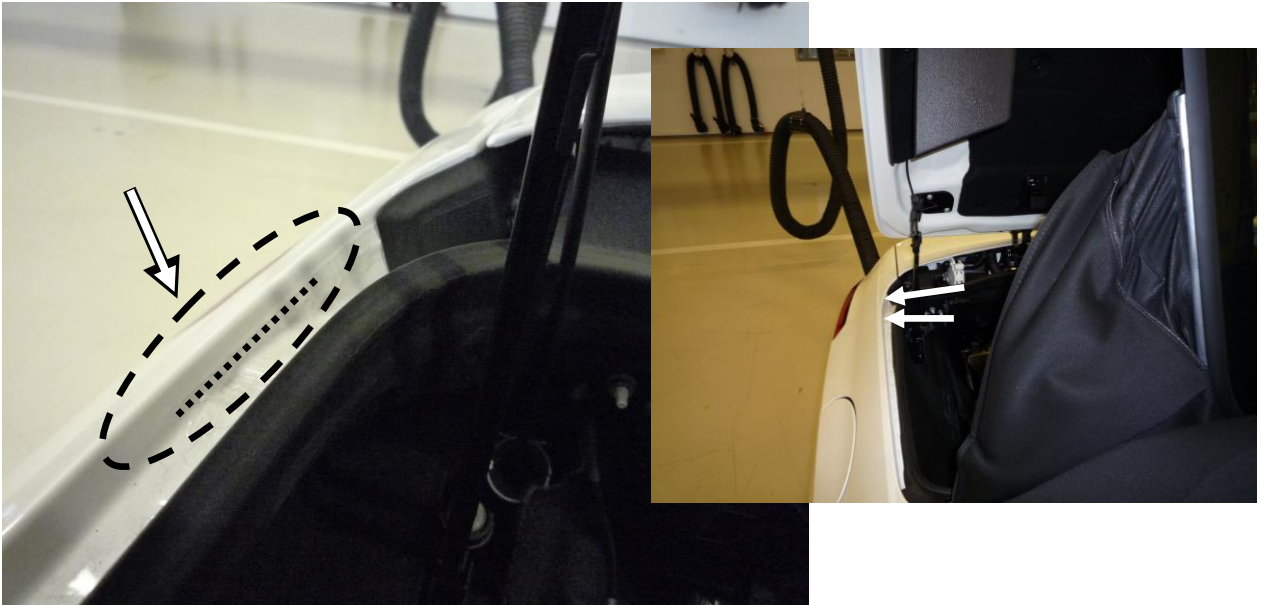
Figure 1

This Service Campaign has been initiated because Daimler AG (DAG), the manufacturer of Mercedes-Benz vehicles, has determined that the seam seal at the trunk may not be to specification. To correct this condition, an authorized Mercedes-Benz dealer will rework the trunk seam seal at the next workshop visit.

Check seam seal at left and right in marked area (arrows, Figure 1) for defects:
 - If seam seal is **OK**: Procedure is complete.
 - If seam seal is **NOT OK**: Proceed to step 3.

3. Repair seam seal:
 - Thoroughly clean area to be repaired.
 - Apply transparent seam sealant.
