B-pillar trim in model series 117 chafed through

Topic number	LI68.30-P-059216
Version	1
Design group	68.30 Coverings, trim
Date	06-16-2014
Validity	Model series 117
Reason for change	
Reason for block

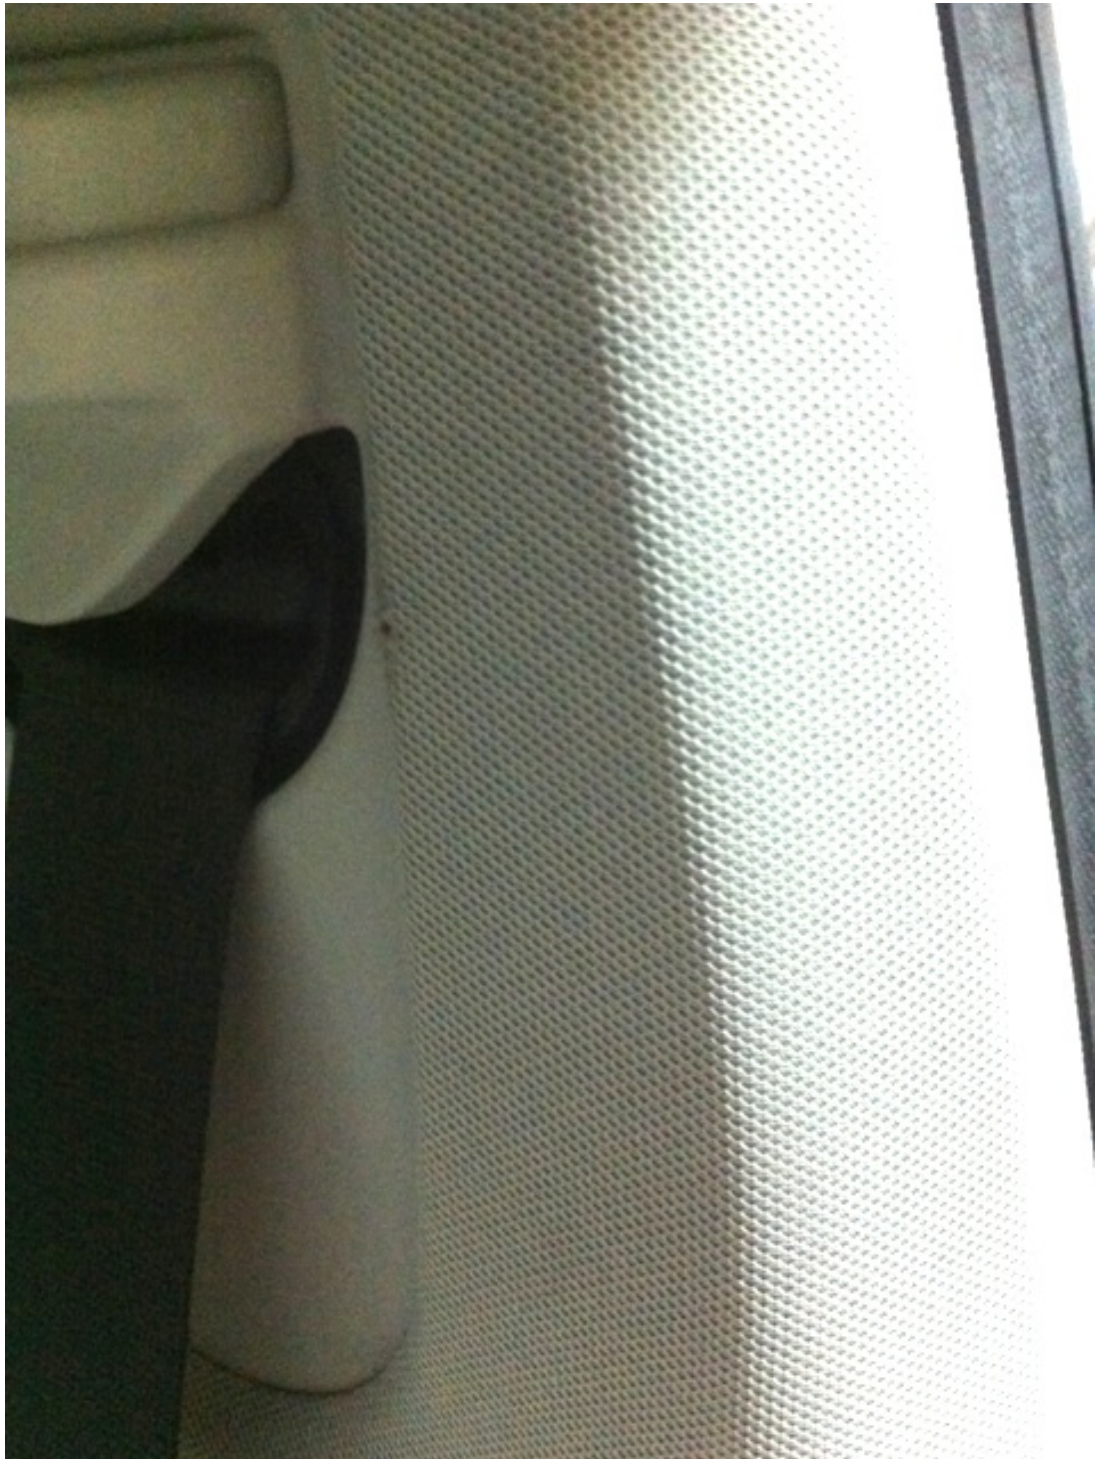
CLA 001.jpg:

The B-pillar trim in model series 117 is chafed through at the height of the belt outlet.

The seat belt can chafe through the B-pillar trim.

Replacing the B-pillar trim does NOT remedy the problem at the present time.

A modification is planned for November/ December 2014.

The modified B-pillar trim will appear under a new part number and will be announced via Xentry/TIPS.
