NUMBER: 08-007-14

Incorrect Switch Installed On The Steering Wheel

2014 (RT) Town and Country

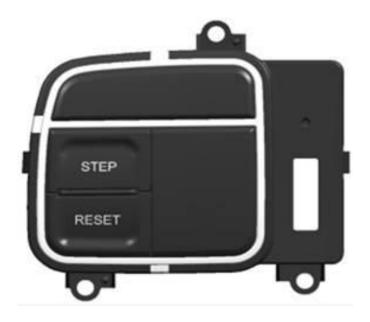
Correct Switch

1 - Two button switch

- 1. Remove the EVIC switch and install the correct part.
- 2. Follow the replacement procedure in DealerConnect, 08 Electrical/8M Message Systems/Message Center/SWITCH, EVIC Control/Removal/Installation.

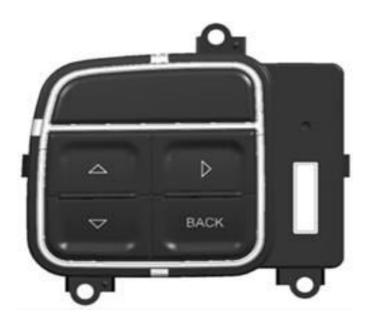
Incorrect Switch

Customer and or dealer may notices that the steering wheel has the incorrect switch assembly installed. The installed switch is for vehicles that are equipped with an EVIC.

1 - Four button switch
