**NUMBER:** 08-011-14

Flash: Hands Free Module Defaults To English Instead Of Last Language Selected

This Bulletin involves performing a USB service flash of the Hands Free Module (HFM).

2012- <b>**2013**</b>	(JC)	Journey (International only)
2012- <b>**2013**</b>	(LD)	Charger (International only)
2012- <b>**2013**</b>	(LX)	300 (International only)

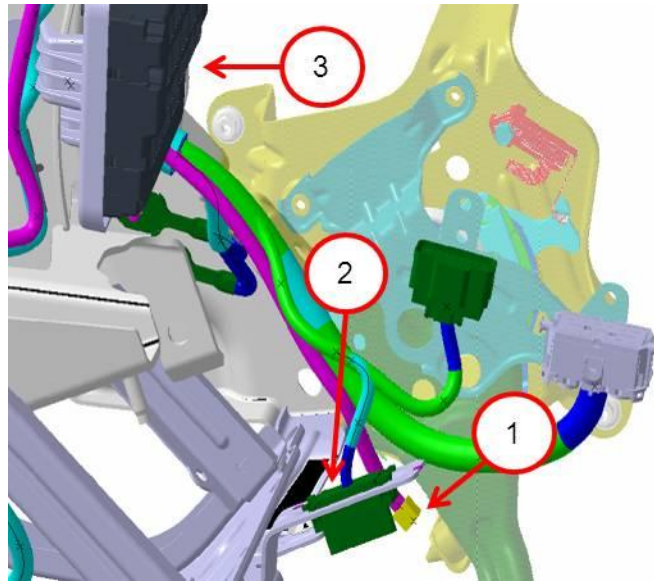
**Fig. 1 JC USB Connector Location**

- 1 - Delphi 4-Way connector (connect wiTECH USB Cable here)
  - 2 - Diagnostics Connector
  - 3 - Hands Free Module
-

**NOTE: For JC vehicles, the wiTECH cable is plugged into the Delphi 4-Way USB connector which is located next to diagnostic connector on the driver side([Fig. 1](#)). For the LD or LX vehicles the wiTECH USB Cable is plugged directly into the HFM Module which is located above the driver's side kick panel ([Fig. 2](#)).**

5. Connect the wiTECH USB Cable to the HFM USB connector only, do not connect Cable to the PC until instructed by wiTECH.

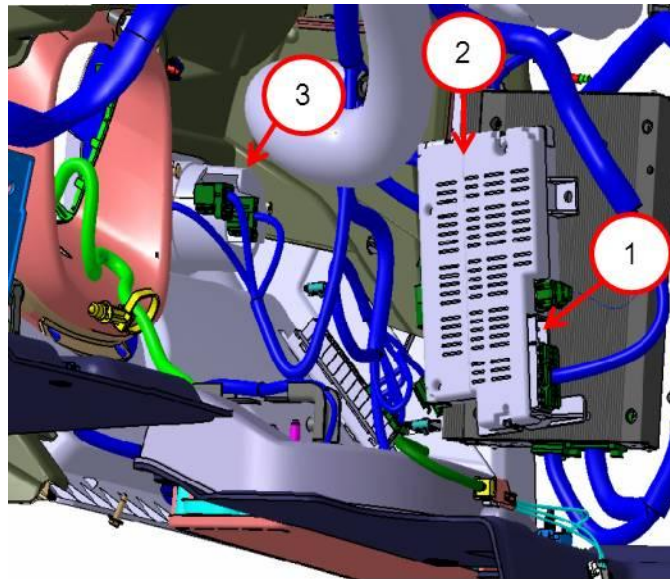
**Fig. 2 LD and LX USB Connector Location**

- 1 - USB Connector Cavity
  - 2 - Hands Free Module
  - 3 - Headlamp Switch
-

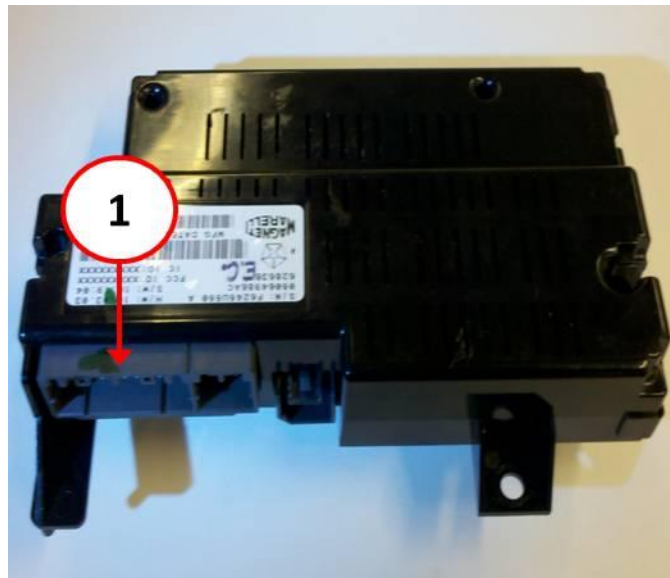
**Fig. 3 HFM Module**

1 - C1 Connector Cavity

**NOTE:** A module reset may be required in the event that an abort recovery is necessary. Procedures vary slightly between LD/LX and JC. LD/LX module power will be reset by removing the C1 connector from the HFM, see (Fig. 3). On JC vehicles, the module power will be reset by removing fuse F131 from the passenger side fuse block, see (Fig. 4).

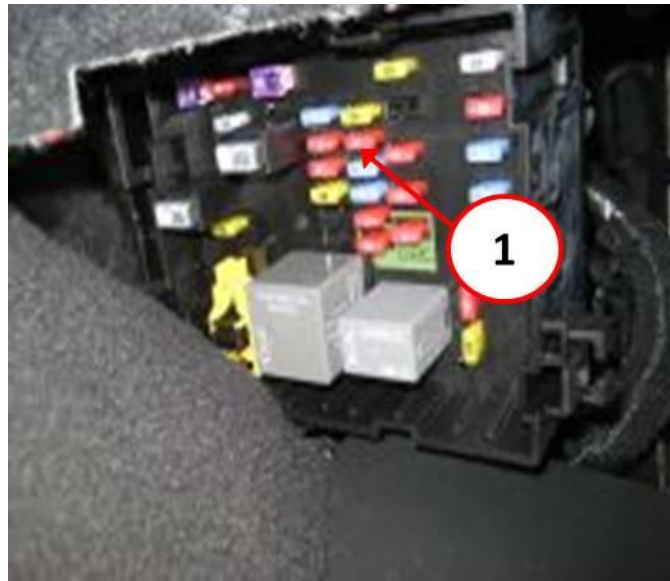
**Fig. 4 JC Passenger Side Fuse Block**

1 -Fuse F131
