**NUMBER:** 08-014-14

Flash: Enable Shift Up Indicator

2013                      (FF)                      500

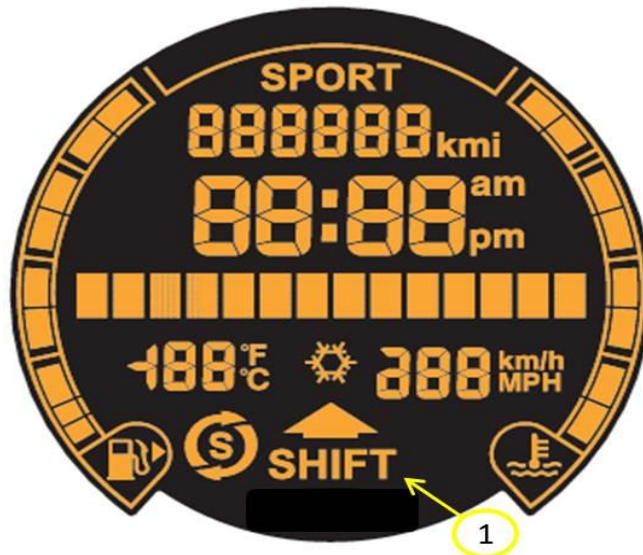
***EVIC Display***

The customer may notice when trying to select the Gear Shift Indicator “GSI Shift Up” in personal setting, the shift indicator doesn’t display in the EVIC.

1 - Shift Indicator

1. Update the software in the Instrument Cluster.
2. Using the wiTECH Diagnostic Application for flashing the module is made available through the wiTECH Diagnostic Application. For instructions select the "HELP" tab on upper portion of the wiTECH window, then "HELP CONTENTS." This will open the Welcome to wiTECH Help screen where help topics can now be selected.
