NUMBER: 08-030-14

SUBJECT:

RB5 RE2 RB6 RE3 RE6 RE4 RE7 RE9 Radio Enhancements

This bulletin involves updating the radio's software and Navigation if required.

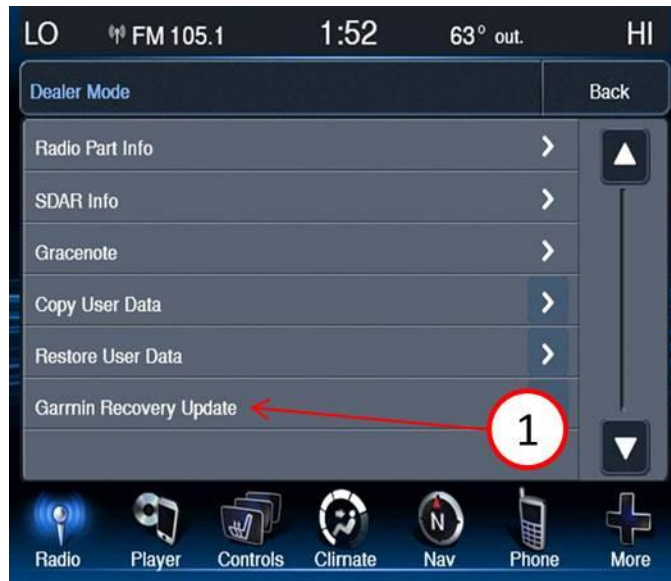
Fig. 1 Press Garmin Recovery Update to begin update

1 - Press soft key to begin

6. When the update is completed, the screen will read “Reflash Successful”. Touch the screen and the radio will reboot.
7. The screen will now show the old and new software, press “No” on the screen to eject the disc.
8. Does this vehicle have one of the following radios, RE2, RE3, RE6 or RE7?
 - a. Yes <<< Only the radio control head needs to be updated, this bulletin has been completed.
 - b. No <<< Navigation updates needs to be performed, proceed to [Step #9](#).
9. Put the radio into dealer mode by press the drives Temp up and down and the front defrost all at the same time until the dealer mode screen is displayed.
10. Press the soft key “Garmin Recovery Update” to begin the navigation update, see ([Fig. 1](#)).

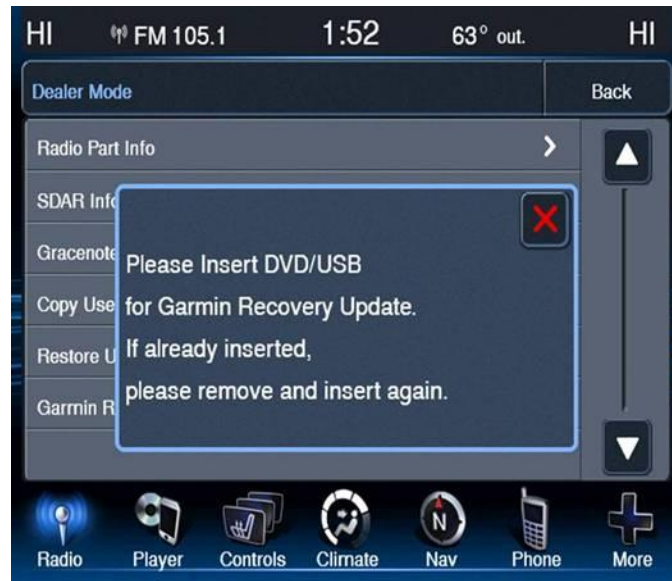
Fig. 2 Insert update when this screen is displayed

1 - Insert the update disc into the CD drive

-
11. To update the navigation system, insert the correct navigation update disc into the CD drive, when this pop up is displayed. see ([Fig. 2](#)).

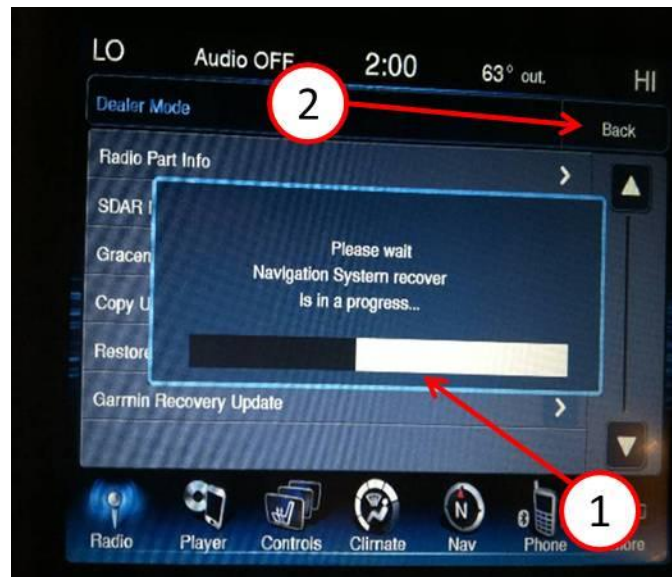
Fig. 3 This screen will be displayed next

1 - Pop up

2 - Soft key, back button

-
12. Navigation system recover, is the first step in the update. When this part is done the pop up will no longer be displayed. This will only take a few minutes.
13. To continue press the "Back" soft key in the upper left hand corner of the screen (Fig. 3).

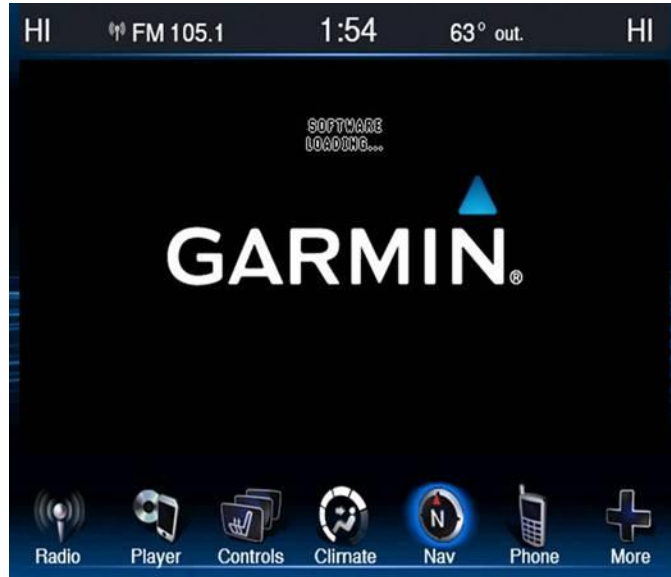
Fig. 4 This screen will be displayed next

1 - Loading software

14. This screen will be displayed when the update is being down loaded, see (Fig. 4).

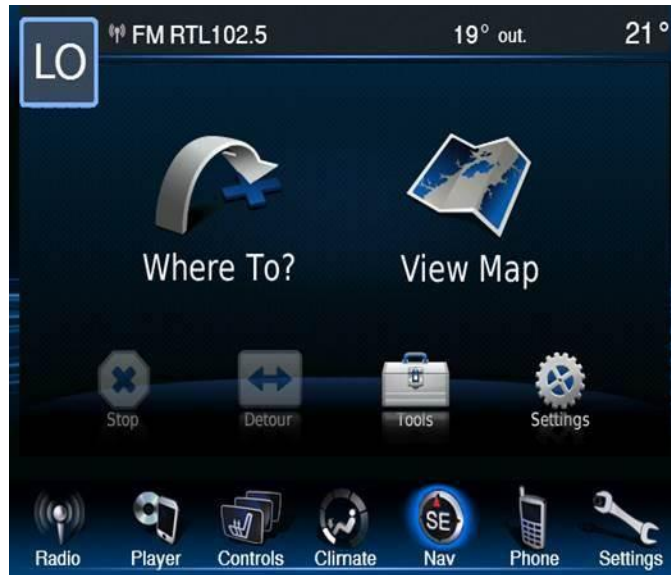
Fig. 5 Navigation Down Load Completed

1 - Navigation software has been updated

15. When the software has completed down loading, the screen will change to the Garmin main screen, see (Fig. 5).
