**NUMBER:** 08-036-14

RA3 RA4 Radio Enhancements

This bulletin involves inspecting and updating the radio software, if required.

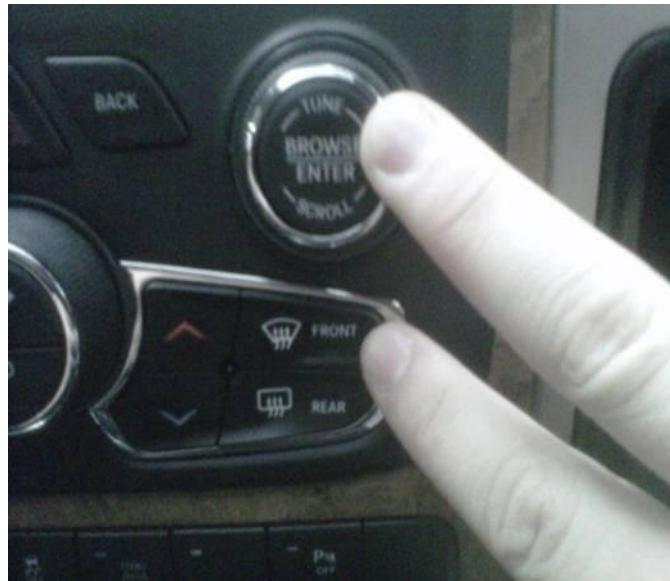
***Fig. 2 Take Vehicle Out of Ship Mode***

1 - Press and hold these buttons, to put the vehicle in and out of ship mode.

- 
4. Turn the engine on and check if the vehicle is still in ship mode. This will be displayed in the Electronic Vehicle Information Center (EVIC).
  5. The vehicle must be in Customer Mode to update the radio. Is the vehicle in Ship Mode?
    - a. Yes >>> Proceed to [Step #6](#).
    - b. No >>> Proceed to [Step #7](#).
  6. Press and hold the 'Enter/Browse' button and the 'Front Defrost' (about 5 seconds) until "Ship Mode" is no longer displayed on the instrument cluster, see ([Fig. 2](#))
