NUMBER: 21-013-14 REV. A

N28 Transmission Oil Cooler Tube Interim Repair

2012-2013 (JK) Wrangler

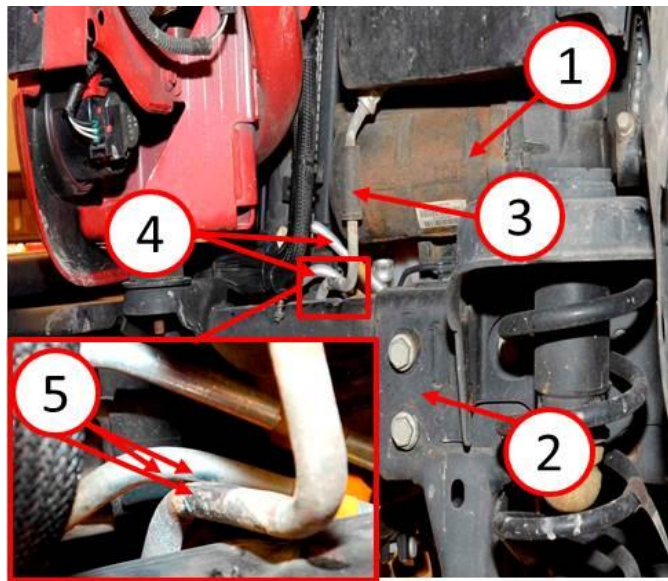
Fig. 3 Inspect TOC Tube

-
4. Using a small inspection mirror, check for wear marks on the transmission oil cooler tube and power steering return tube where they intersect . Were there any wear marks on the transmission oil cooler or power steering return tube (Fig.3)?
 - a. Yes>>> Contact a STAR agent for further assistance at 1-800-850-STAR, select "Part or Labor Operation Restriction". Enter part number (**digits only**) for part number CBRAN283AA (**digits 283**).
 - b. No>>> Proceed to Step 5.

- 1 - Power Steering Pump
- 2 - Left Frame Rail
- 3 - Power Steering Return Tube
- 4 - Transmission Oil Cooler Tubes
- 5 - Suspect Wear Area
