NUMBER: 11-003-14

Rattle Or Squeak Noise Under Vehicle

2014 WK Grand Cherokee

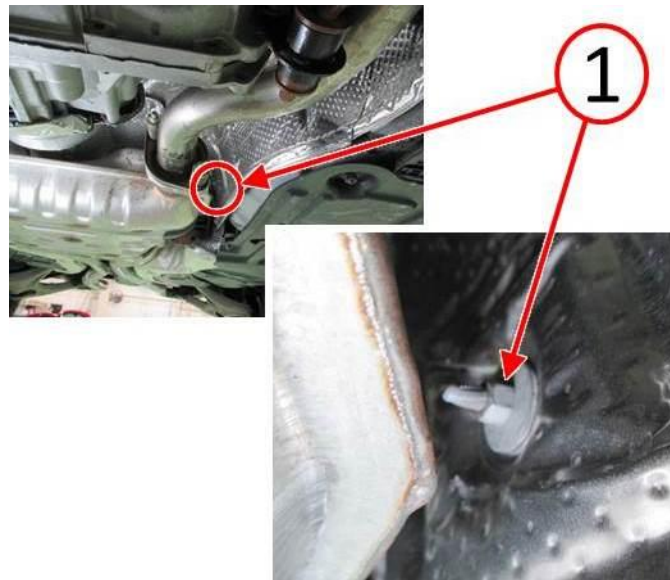
Fig. 2 Inspect For Missing Fastener Nut

1 - Missing Nut

3. Install the nut specified in the PARTS REQUIRED section of this bulletin to the toe pan heat shield, and tighten the nut to 7 N·m (62 in. lbs.).
4. Ensure proper alignment and sufficient gap between the toe pan heat shield and other components.
