Service Bulletin

Bulletin No.: P11326

Subject: Rear Doors Passive Entry Switch Inoperative

Models: 2015 Chevrolet Impala
Equipped with Passive Entry (RPO ATH)

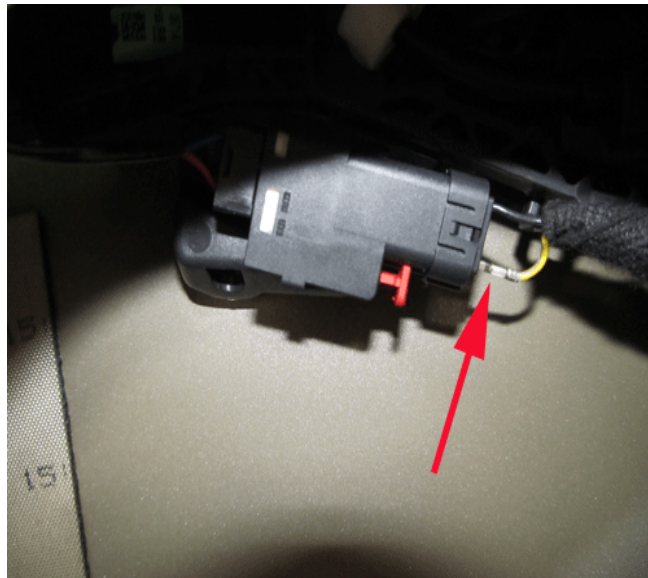
3973485

Some customers may comment that the rear door(s) passive entry switch is inoperative.

This may be caused by the door harness not having enough length for the outside door handle passive entry connector causing high tension on the harness, resulting in the terminals to be pulled out of the connector.

If the passive entry connector terminal(s) are pulled out or not retained properly in the connector (A24RR or A24LR) as shown above, replace both rear door harnesses and modify the new door harness prior to installing. Follow the instructions listed below:
