# Service Bulletin

## PRELIMINARY INFORMATION

**Subject:** Information on Water Pump Replacement

**Models:** 2013-2014 Buick Encore Equipped with Engine RPO LUJ, LUV  
2014 Cadillac ELR Equipped with Engine RPO LUU  
2011-2014 Chevrolet Cruze Equipped with Engine RPO LUJ, LUV  
2011-2014 Chevrolet Volt Equipped with Engine RPO LUU  
2012-2014 Chevrolet Sonic Equipped with Engine RPO LUJ, LUV  
2013-2014 Chevrolet Trax Equipped with Engine RPO LUJ, LUV

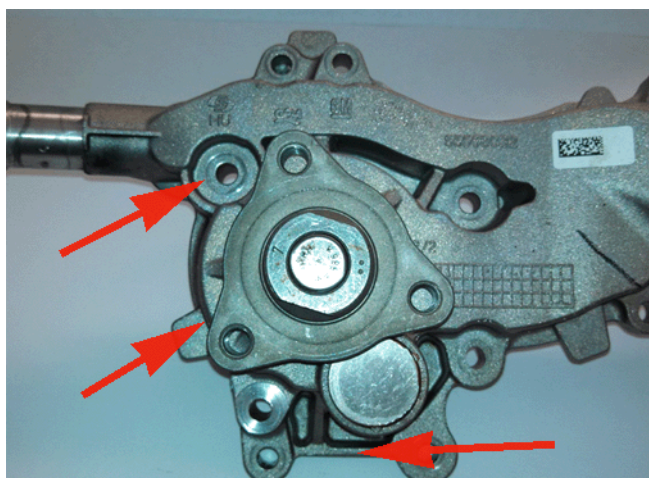
If the water pump housing shows minimal coolant deposits as shown below, do not replace the pump. The water pump is functioning as designed.

- No evidence of coolant leakage on the pump body.

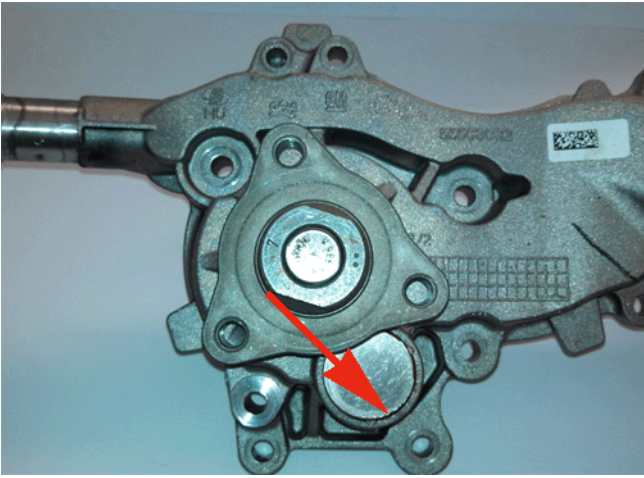
- Slight coolant staining around the perimeter of the cover plate.

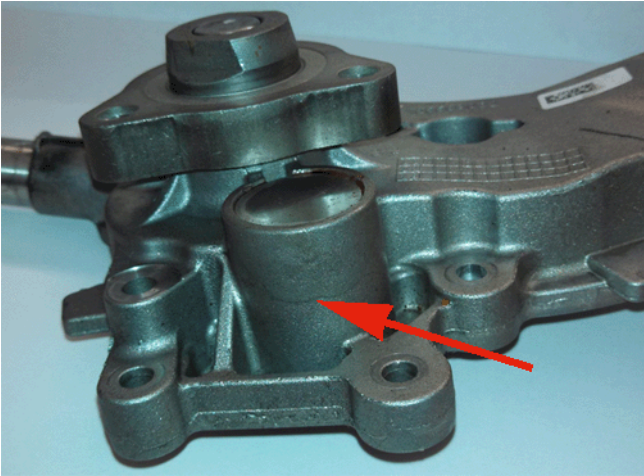
- Slight coolant staining on the underside of the housing.

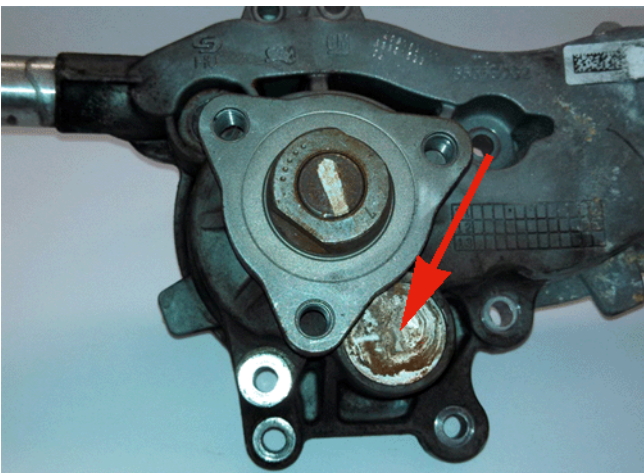
If the pump housing displays excessive evidence of leaking as shown below, replace the pump. Refer to Water Pump Replacement in SI.

- Significant coolant residue on the cover plate.

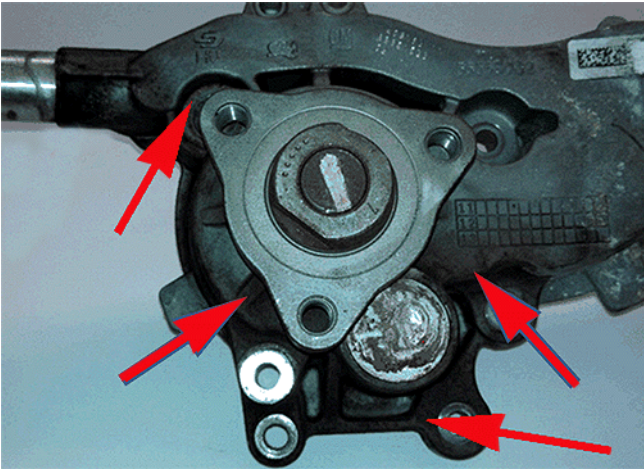
- Evidence of coolant residue on the exterior surfaces of the pump housing.
