Service Bulletin

Subject: Squeaking/Creaking Type Noise Heard When Using Clutch Pedal

Models: 2012-2013 Chevrolet Cruze Equipped with Manual Transmission (RPOs MF3, MR5, MZ0)
2012-2013 Chevrolet Sonic Equipped with Manual Transmission (RPOs MZ4, M26)

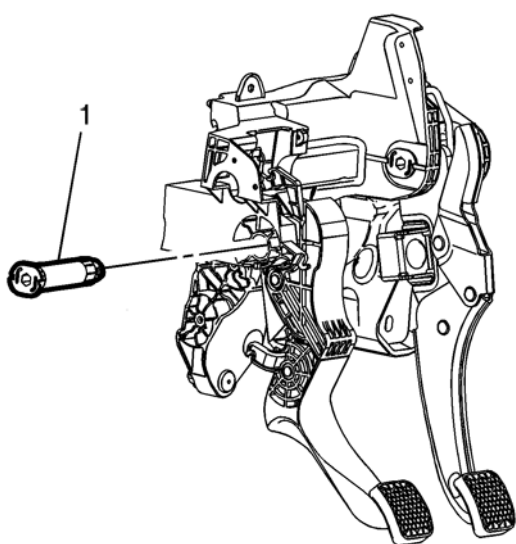
Some customers may comment on a squeaking/creaking type noise heard when using the clutch pedal.

This may be caused from lack of or no lubrication on the clutch pedal pin (1) shown in the illustration above.
