Service Bulletin

Subject: Intermittent Radio Shut Off, Instrument Cluster Gauges Inoperative, Blind Spot Indicator Flashing, Multiple Communication Codes Set

Models: 2013-2014 Buick Enclave
2013-2014 Chevrolet Traverse
2013-2014 GMC Acadia

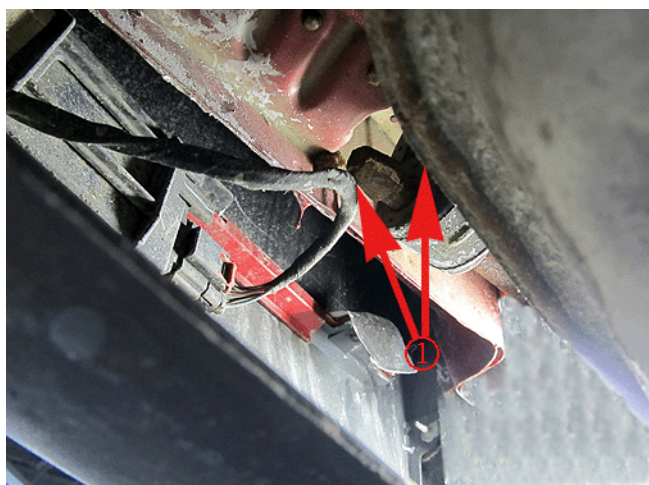
This condition may be caused by the side object detection sensor wiring harness, located in the rear of the vehicle, making contact with the exhaust system. This contact may wear through the wiring insulation, affecting the LAN communications.

1. Locate the side object detection sensor wiring harness on the right rear of the vehicle between the exhaust muffler and the rear compartment floor lower extension.

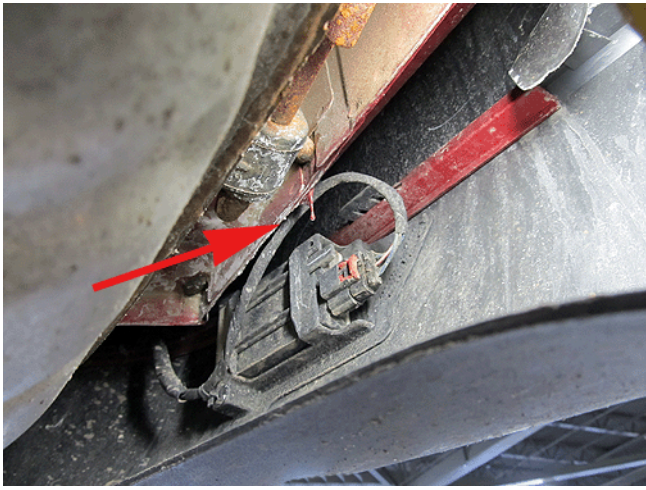
2. Inspect the wiring harness for a contact condition with the muffler or exhaust mounting (1). Check for worn through wiring insulation, burned wire insulation or broken wires.
3. Repair any wiring as required. Refer to GMLAN and Media Oriented Systems Transport (MOST) Wiring Repairs in SI for specific repair procedures.
4. Reposition the wiring harness to prevent contact with exhaust components.

Position the harness outboard of the rear compartment floor lower extension as shown. It may be necessary to loop the wiring over itself and secure with a wire tie to take up any excess slack in the wiring.
