Service Bulletin

Bulletin No.: 09-03-08-004E

Subject: Squawk or Creak Type Noise from Front of Vehicle

Models: 2008-2014 Buick Enclave
2009-2014 Chevrolet Traverse
2007-2014 GMC Acadia
2007-2010 Saturn OUTLOOK

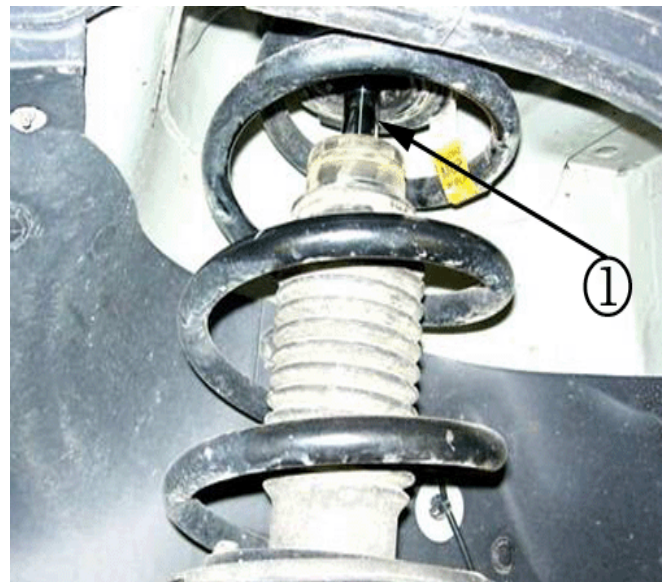
2246522

The cause of this condition at cold weather conditions may be due to the inside diameter of the front strut jounce bumper rubbing against the piston rod of the strut, creating a slip-stick condition.

3. Pull the dust boot/jounce bumper assembly out of the strut mount jounce cup (1).
4. Slide the dust tube/jounce bumper assembly down to expose the top portion of the piston rod (1). A long screwdriver or pry bar may be required to pop the dust boot/jounce bumper assembly from the mount cup.
5. Apply grease, GM P/N 12345579 (in Canada, 10953481), around the circumference of the piston rod **ONLY** in the exposed area (to top 25 mm (1 in) of the piston rod, measured from bottom of mount cup).
6. Raise the dust tube/jounce bumper assembly up to the mount cup.

7. Rotate the dust tube/jounce bumper assembly on the piston rod to ensure grease is distributed around the rod.
8. Re-seat the dust tube/jounce bumper assembly into the mount cup.
