# Service Bulletin

Bulletin No.: PI1241

**Subject:** Tire Pressure Monitor (TPM) Light On and/or Loss of TPM Reading Displayed on DIC

**Models:** 2013-2014 Chevrolet Camaro  
Equipped with Remote Start (RPO S6P)

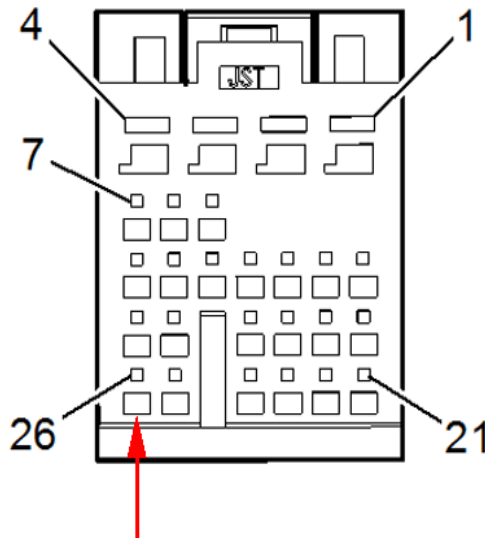
3815886

K9 Body Control Module (BCM) X1 shown in the illustration above.

12. Crimp the terminal SNAC-A061T-M2.8 on lead 3 of the remote control door lock receiver. Remove the old terminal before installing the new terminal into cavity 26 of the K9 Body Control Module (BCM) X1 connector, shown in the illustration above.

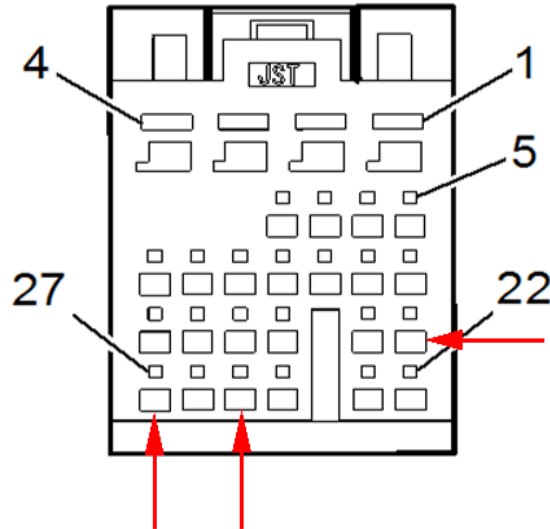
3815884

K9 Body Control Module (BCM) X2 shown in the illustration above.

10. Crimp the terminal SNAC-A061T-M2.8 on lead 1 of the remote control door lock receiver. Remove the old terminal before installing the new terminal into cavity 16 of the K9 Body Control Module (BCM) X2 connector, shown in the illustration above.

11. Crimp the terminal SNAC-A061T-M2.8 on lead 2 of the remote control door lock receiver. Remove the old terminal before installing the new terminal into cavity 27 of the K9 Body Control Module (BCM) X2 connector, shown in the illustration above.

13. Crimp the terminal SNAC-A061T-M2.8 on lead 4 of the remote control door lock receiver. Remove the old terminal before installing the new terminal into cavity 25 of the K9 Body Control Module (BCM) X2 connector, shown in the illustration above.
