Service Bulletin

Bulletin No.: PI1243

Subject: Rattle or Popping Noise Heard in Rear Hatch Area

Models: 2011-2014 Chevrolet Volt

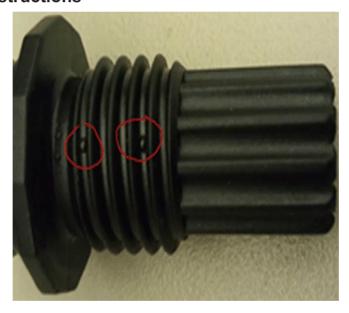
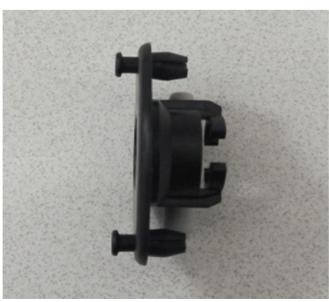
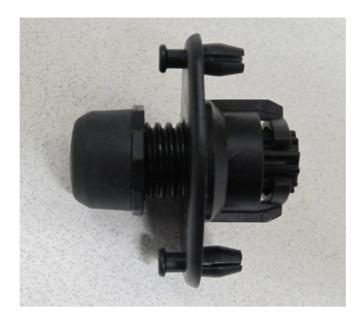
This condition may be due to the lower liftgate bumpers rattling in the threads of the bumper housing or the housing rubbing on the metal hatch frame.

Inspect to see if both rear bumpers have dimples on the thread as shown above. If no dimples are present, replace both RH and LH liftgate bumpers. Use BRS tape to make a gasket that will fit around the housing of the bumper before installation, following the procedure listed below:
