Service Bulletin

Subject: Mobile Telephone Microphone Poor Performance

Models: 2013-2014 Cadillac ATS
2014 Cadillac CTS Sedan
All Built Prior to October 18, 2013

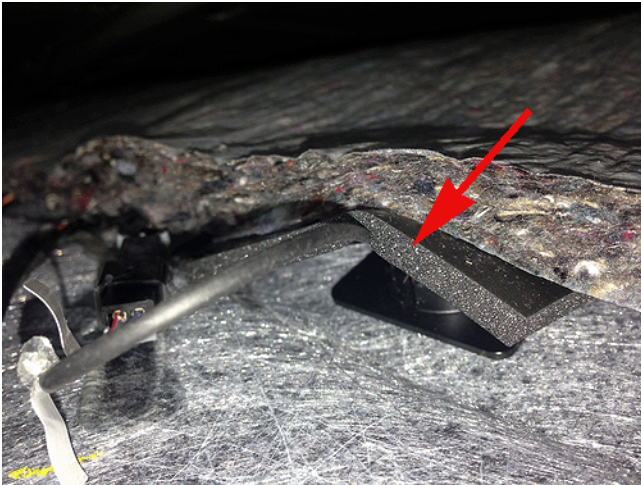
The foam patch on the back of the headliner at the microphone mounting area may have come loose. This foam is a sound barrier for the back side of the microphone. If the patch is detached, it allows unwanted noise to interfere with the microphone operation when making a phone call.

Use the following steps to install a larger foam rubber patch to the microphone area and reattach any loose wire harnesses to the headliner.
