Bulletin No.: 08-03-10-006E

# Service Bulletin

**Subject:** Tire Slowly Goes Flat, Tire Air Loss, Low Tire Pressure Warning Light Illuminated, Aluminum Wheel Bead Seat Corrosion (Clean and Resurface Wheel Bead Seat)

**Models:** 2005-2015 GM Passenger Cars and Light Duty Trucks

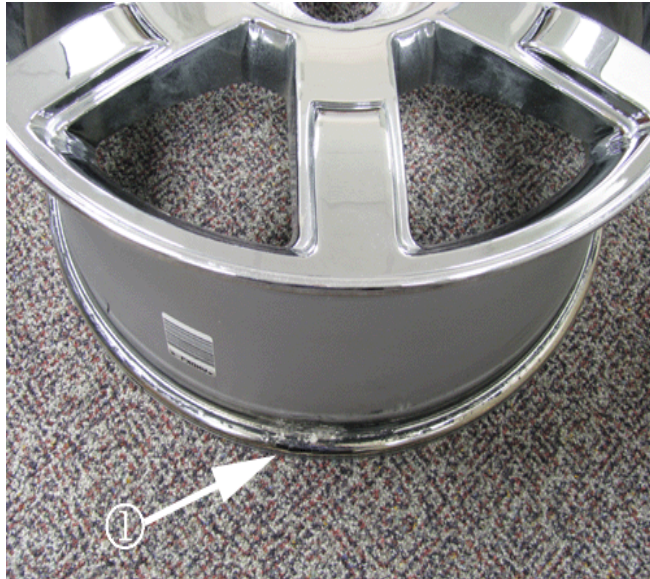
2103715

1. Remove the wheel and tire assembly for diagnosis. Refer to Tire and Wheel Removal and Installation in SI.
2. After a water dunk tank leak test, if you determine the source of the air leak to be around the bead seat of the wheel, dismantle the tire to examine the bead seat. Shown below is a typical area of bead seat corrosion.

## Typical Location of Bead Seat Corrosion

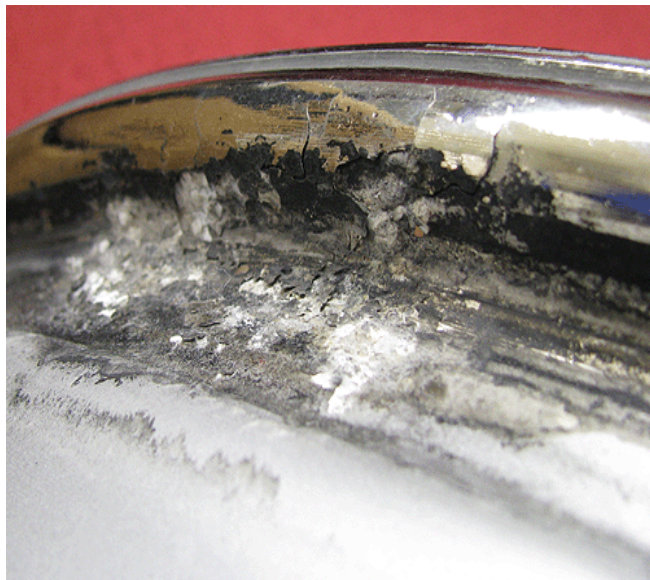
2103722

3. Bead seat corrosion is identified by what appears like blistering of the wheel finish, causing a rough or uneven surface that is difficult for the tire to maintain a proper seal on. Below is a close-up photo of bead seat corrosion on an aluminum wheel that was sufficient to cause slow air loss.

## Close-Up of Bead Seat Corrosion

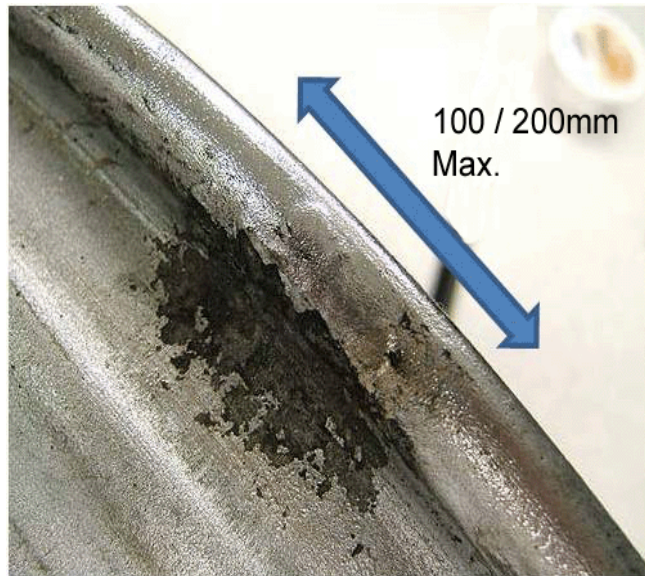
2365347

4. If corrosion is found on the wheel bead seat, measure the affected area as shown below.

- For vehicles with 32,186 km (20,000 mi) or less, the total allowable combined linear area of repairable corrosion is 100 mm (4 in) or less. If the total area(s) of corrosion exceed these dimensions, the wheel should be replaced.

- For vehicles that have exceeded 32,186 km (20,000 mi), the total allowable combined linear area of repairable corrosion is 200 mm (8 in) or less. If the total area(s) of corrosion exceed these dimensions, the wheel should be replaced.

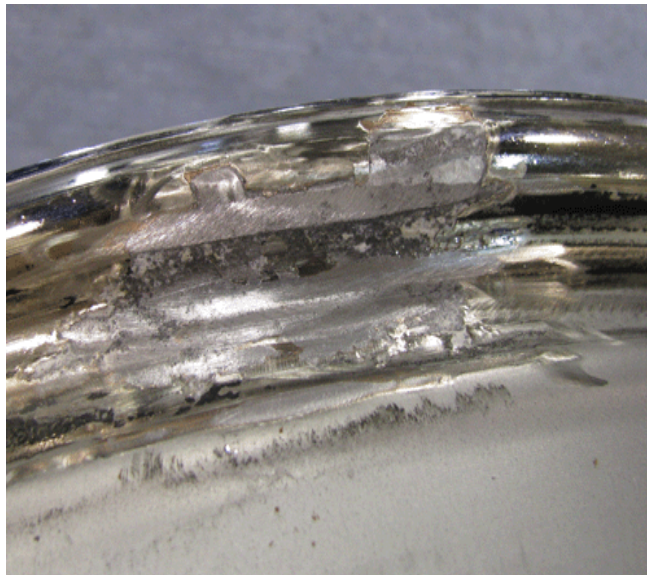
2103726

### Acceptably Prepared (Cleaned-Up) Wheel Surface

5. In order to correct the wheel leak, use a clean-up (fine cut) sanding disc or biscuit to remove the corrosion and any flaking paint. You should remove the corrosion back far enough until you reach material that is stable and firmly bonded to the wheel. Try to taper the edge of any flaking paint as best you can in order to avoid sharp edges that may increase the chance of a leak reoccurring. The photo below shows an acceptable repaired surface.

**Important:** Remove ONLY the material required to eliminate the corrosion from the bead seating surface. DO NOT remove excessive amounts of material. ALWAYS keep the sealing surface as smooth and level as possible.

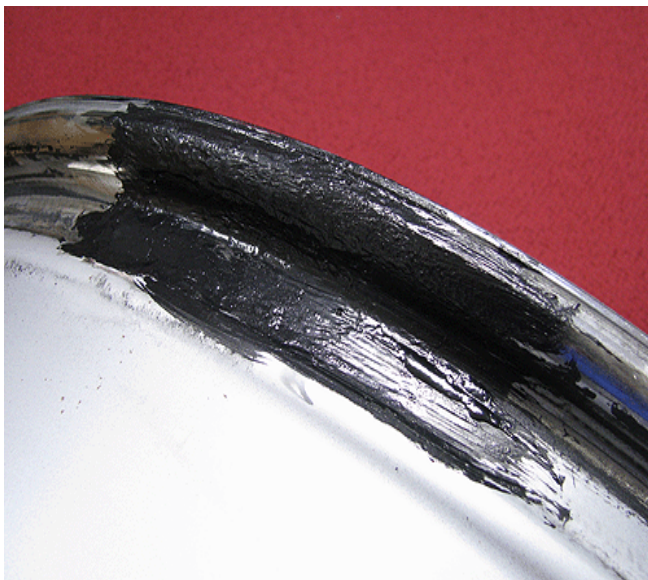
2103731

### Coated and Sealed Bead Seat

- Once the corrosion has been eliminated, you should coat the repaired area with a commercially available tire sealant such as Patch Brand Bead Sealant or equivalent. Commercially available bead sealants are black rubber-like coatings that will permanently fill and seal the resurfaced bead seat. At 21°C (70°F) ambient temperature, this sealant will set-up sufficiently for tire mounting in about 10 minutes.
