Service Bulletin

Subject: Groan, Squeak or Rubbing Type Noise When Turning Steering Wheel

Models: 2010-2014 Buick LaCrosse
2012-2014 Buick Regal
2014 Chevrolet Impala
2013-2014 Chevrolet Malibu

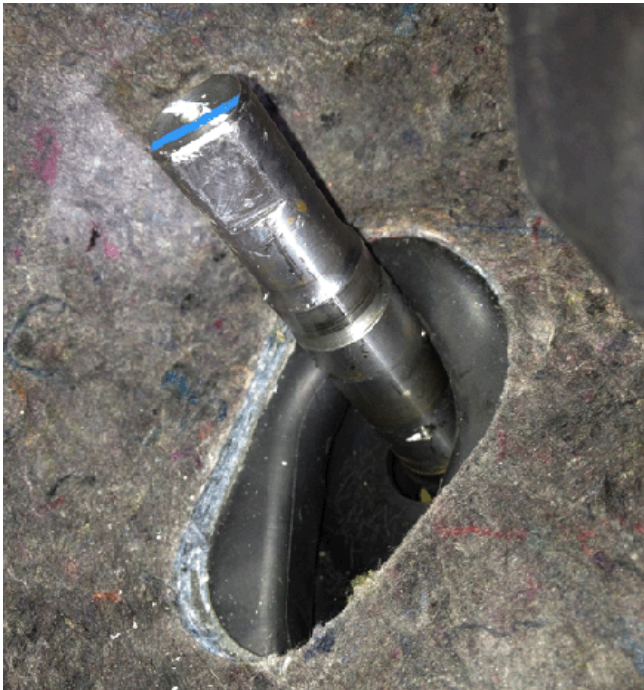
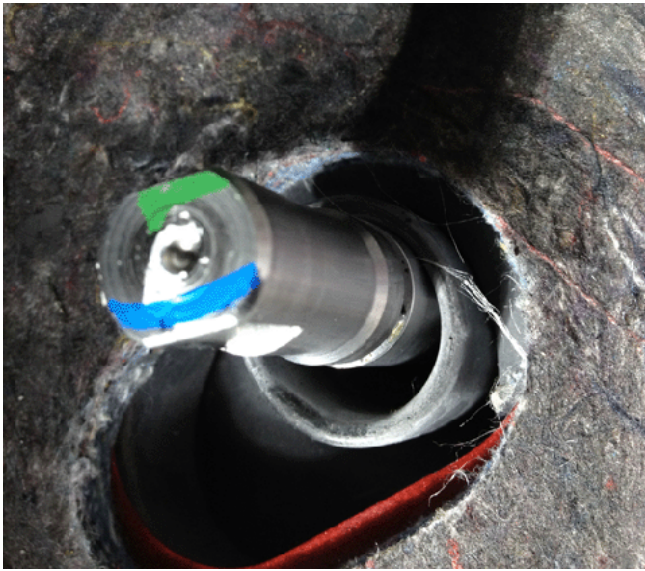
Some customers may comment on a rubber squeak type noise when turning the steering wheel. This condition may be caused by the seal for the intermediate shaft, located at the front of dash, rubbing on the rotating intermediate steering shaft. Refer to the pictures above. On electronic power steering (EPS) equipped vehicles, the EPS wire harness bracket may be contacting the steering column seal.

Technicians should inspect the steering column seal for proper installation by repositioning the inner intermediate steering shaft boot assembly to gain access. Inspect the seal at the front of the dash where the intermediate steering shaft passes through from the steering gear. Ensure that the seal is centered in the opening and around the intermediate steering shaft as shown above. If the seal is out of position, replace the steering column seal following the steps below.
